July 5, 2023

Stillwater River Flood Rehabilitation River Assessment Triage Team (RATT) 2023 Report - Executive Summary

Stillwater Valley Watershed Council

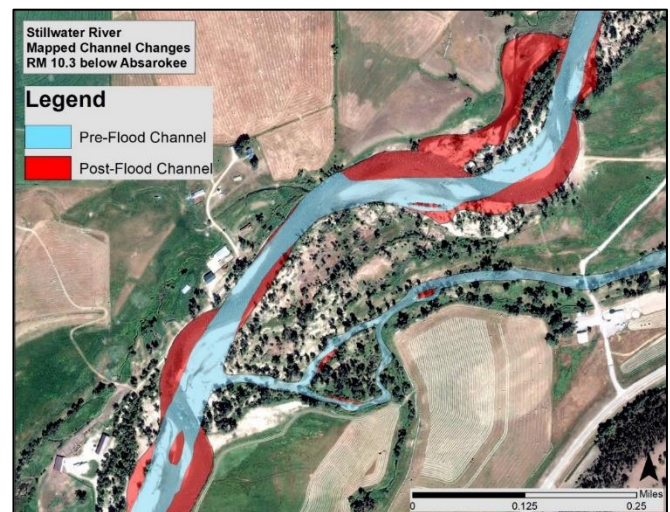
Bank erosion was one of the most extensive and visible flood impacts. Digitized pre- and post-flood banklines indicate that just over 300 total acres of ground was eroded during the flood, with the vast majority on the Stillwater River and East Rosebud Creek. Figure 1 shows an example of the mapping, which is available for the Stillwater River (Sibanye-Stillwater Mine to Columbus) East Rosebud Creek (5.6 miles above the Forest Service Boundary to mouth), West Rosebud Creek (1.9 miles above Forest Service Boundary to mouth), and Rosebud Creek.

Figure 1. Example bankline mapping showing pre- and post-flood banklines capturing erosion location and extent, Stillwater River RM 10.3 below Absarokee

1. Prioritize need, take a wait-and-see approach (NO ACTION) if possible.
2. Reduce bank angle to 3:1 if possible.
3. Consider alternatives to full-bank quarried rock riprap. Use wood/alluvium as treatment where infrastructure is not under immediate threat.

4. Concentrate on toe treatments along the base of the re-sloped bank; do not carry rock above the normal high water mark. Use vegetative treatments on upper bank slopes (See Appendix A for examples).

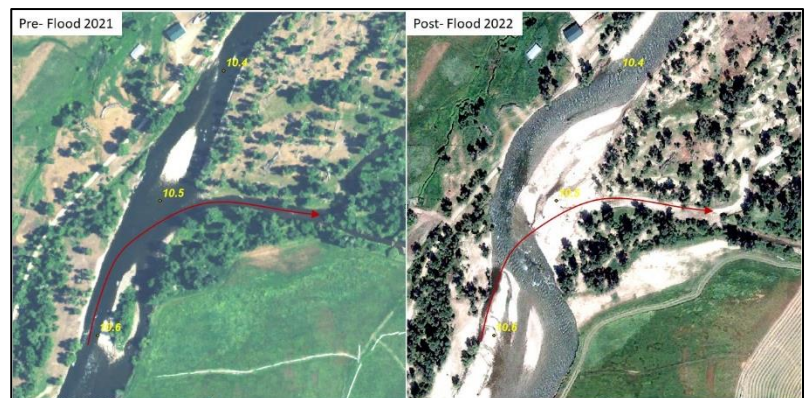
Channel infilling with coarse bedload sediment was a common flood impact. This included deposition of new point bars and deposition within/at the heads of existing side channels (Figure 2). An estimated 10.8 miles of channels have become isolated due to deposition, some of which have sediment concentrated at their entrances and others throughout their length.

Figure 2. Large point bar deposition and loss of side channel on Stillwater River, RM 10.5

1. Reactivate side channels by excavating sediment/building apex log jams at heads of islands.
2. Skim tops of bars versus removing entire feature to maintain a low flow channel.
3. Retain wood jams and woody debris that aren't creating problems to improve habitat diversity.
4. Restore side channels that have aggraded to improve conveyance/habitat.

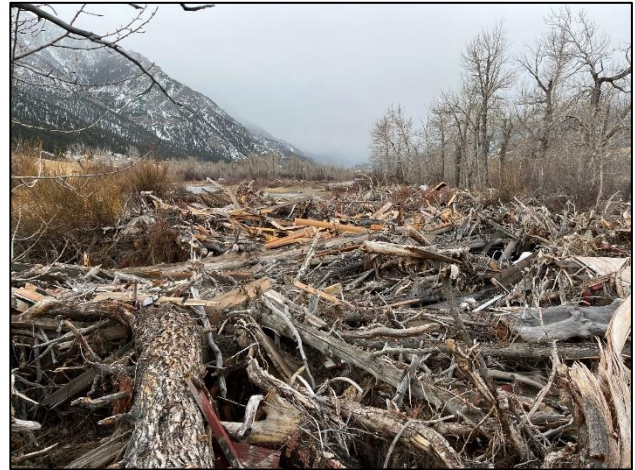
Debris accumulations were extensive on the river and included both man-made materials as well as large wood (Figure 3).

Figure 3. Example debris accumulation on upper Stillwater.

1. Rearrange floodplain wood and create openings along side channels and sloughs to better route overflows back to channel.
2. Concentrate wood at points of overflow to reduce overflow volumes.
3. Leave scattered wood in developing overflow channels to prevent their capture of the main thread.
4. Where possible, relocate wood to use as bank treatments; anchor with boulders to minimize risk of remobilization.
5. Creative incorporation of large woody debris such as root wads into restoration work can significantly improve fish habitat.

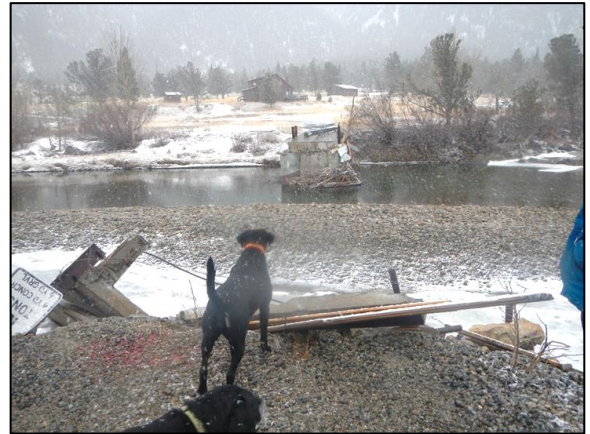
A total of 59 bridges were mapped in the assessment reaches, and 13 of those were completely destroyed by the flood. All the destroyed bridges were on either the Stillwater River or East Rosebud Creek. Several bridges provided primary access for residences such as the Rainbow Ranch Subdivision on the upper Stillwater (Figure 4). Other bridges visited in the field were substantially damaged but did not fail.

Figure 4. Upper Stillwater Bridge failure (RM 39.3); bridge provided the primary access route for the Rainbow Ranch Subdivision.

1. Remove old or destroyed bridge piers, spans and remnants when replacing structure/restoring site.
2. Make sure bridge piers are designed to withstand bed scour.
3. Replace bridges with spans of sufficient length to avoid constricting the river which leads to excessive scour and greater flood stages.
4. Eliminate and do not create hazards for other river users floating the river or utilizing the zone below the ordinary high water marks.
