Memorandum

To: Lindsey Clark, Stillwater Valley Watershed Council Coordinator
From: Chad Raisland, Pioneer Technical Services, Inc. and Karin Boyd, Applied Geomorphology, Inc.
CC: Tanya Lester, Stillwater Conservation District Administrator
Date: 8/2/2016
Re: West Fork Stillwater River Avulsion Assessment

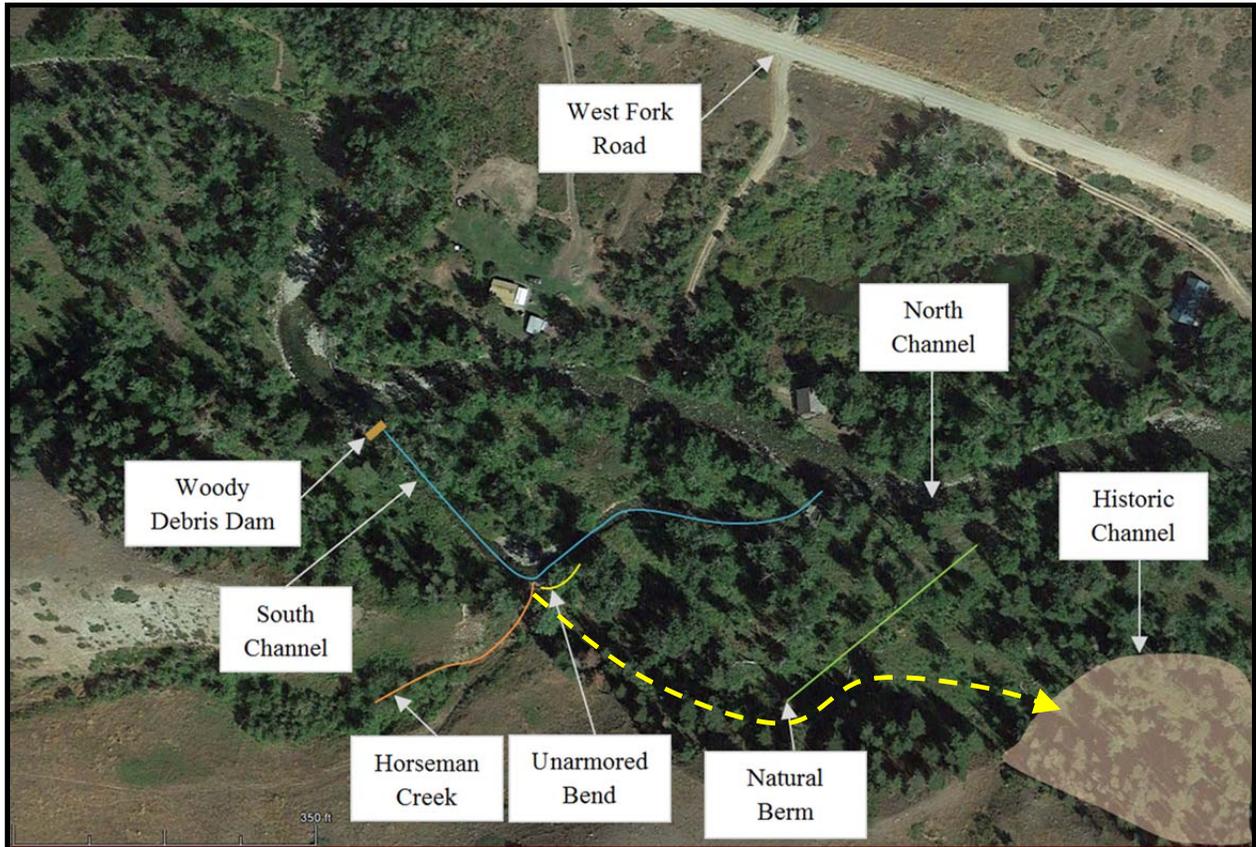
The project site was identified as having a risk of avulsion in the Upper Stillwater Watershed Assessment (Kellogg, 2014). The assessment noted that the bendway migration that occurred on a side channel of the West Fork during high water in 2011 increased the risk of the West Fork being captured by a historic channel that could cause erosion and flood damages in Nye. Figure 2 shows several features at the project site that relate to the potential avulsion issue. The “North Channel” is the main thread of the West Fork. It is a steep, boulder bed channel that carries coarse glacially derived bedload material. The “South Channel” refers to the side channel that has enlarged with recent flooding (notably 2011). The South Channel is blocked at its entrance by a woody debris jam, which currently limits flow into the South Channel (see Figure 3). Just downstream of the debris jam, however, the South Channel shows evidence of flood-induced enlargement, downcutting, and migration (see Figure 4), including high eroding banks, a distinct headcut, and variable bank heights due to headcut migration. One concern is that the failure of the debris jam at the entrance of the South Channel may cause it to enlarge further and potentially become a more prominent secondary channel or even the main thread of the West Fork. This would in turn increase the frequency and duration of overbank flows into the area where the historic channel flows towards Nye. Increased flow into the South Channel could also drive its migration down valley into the historic channel area.

Figure 2. Project site overview (avulsion path of concern in yellow).

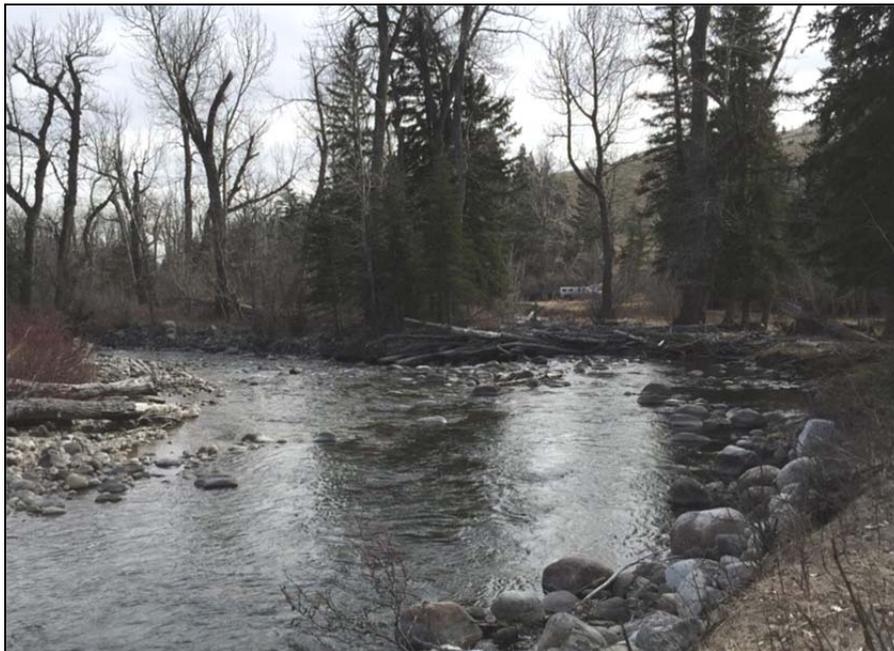
Figure 3. Debris jam at the entrance of the South Channel (main thread of the West Fork flows to the left).

The relocation of the majority of the West Fork flow into the South Channel would increase the risk of subsequent avulsion into the historic channel. Typical drivers for this could include debris or ice blockages on the main channel, or perching of the main channel above the South Channel, making the current flow split unstable. A major blockage of the main West Fork channel ("North Channel" shown on Figure 2) may be the most likely scenario for wholesale flow relocation into the South Channel. This would require a blockage to form in the North Channel somewhere near the entrance of the South Channel, which is currently blocked by a debris jam of its own. Thus, a major relocation of flow would require blockage of the main North Channel and simultaneous breaching of the existing debris jam at the entrance of the South Channel (see Figure 3).

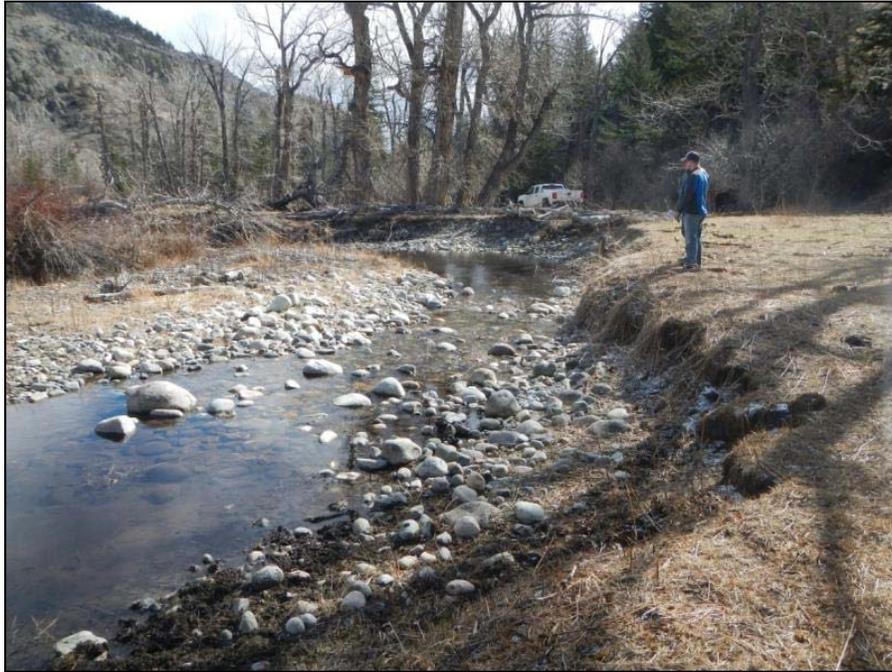
Figure 4. View down the South Channel showing unarmored bendway (avulsion point of concern is at the pickup).

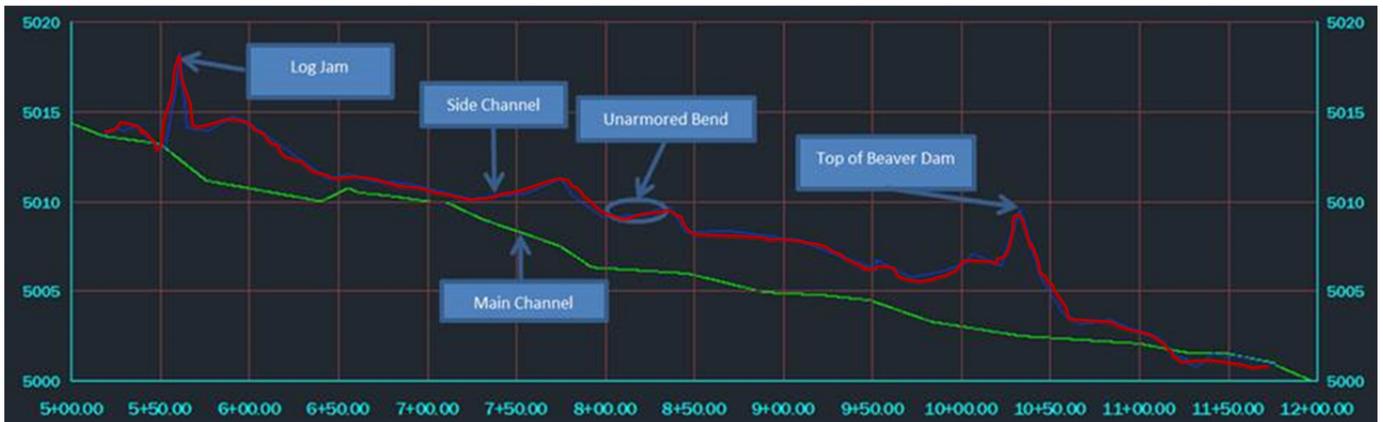
With regard to topographic perching, a survey of the project site indicates that the secondary South Channel is currently perched above the main North Channel (see Figure 5), which greatly reduces the potential for the South Channel to capture the main thread flow of the West Fork.

Figure 5. Surveyed profile of the main North Channel (green) and secondary South Channel (red) showing perching of the South Channel.

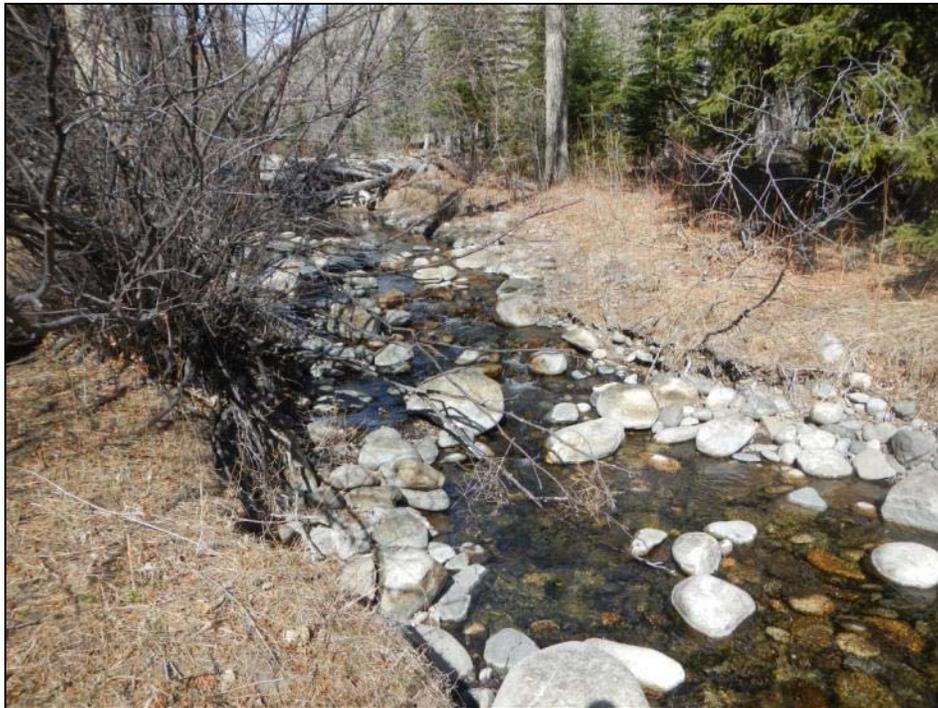
The bed of the South Channel is covered in coarse boulders that probably accumulated as an armor layer during the flood-induced erosion of 2011. In the event that the channel receives more flow, this coarse boulder material will help resist continued channel enlargement under most flow conditions. In the event of an extreme event, however, the boulders should be considered mobile (see Figure 6).

Figure 6. View upstream of South Channel showing boulder bed material.

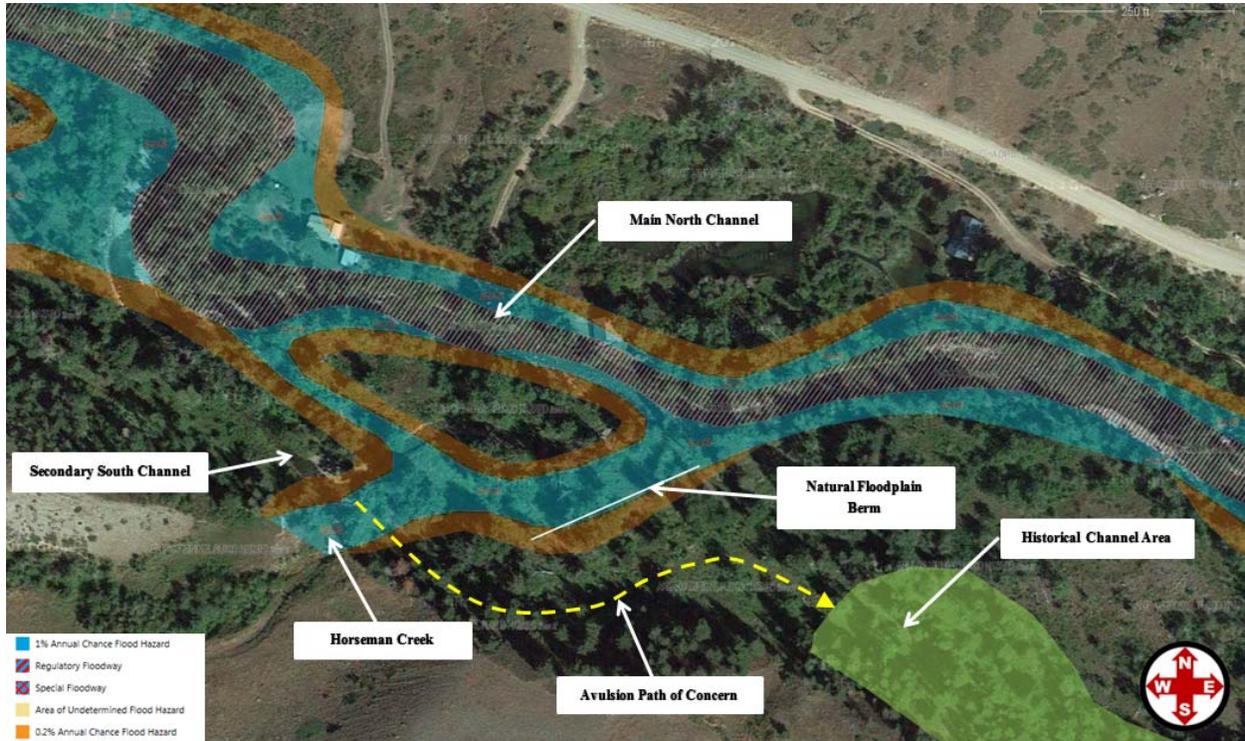
If flood flows were to extend across the floodplain surface and reach the head of the historic channel, there is a possibility that those overbank flows would concentrate in historic channel and enlarge it, which could create upstream migrating headcuts that would increase the risk of wholesale avulsion. The primary mechanisms for this scenario would include floodwater access to the floodplain channel and erosion of that feature. Figure 7 shows that the “Historic

Figure 7. Stillwater County FIRM map of the project site showing the historical channel area outside the 100-Year floodplain and separated by a natural floodplain berm.

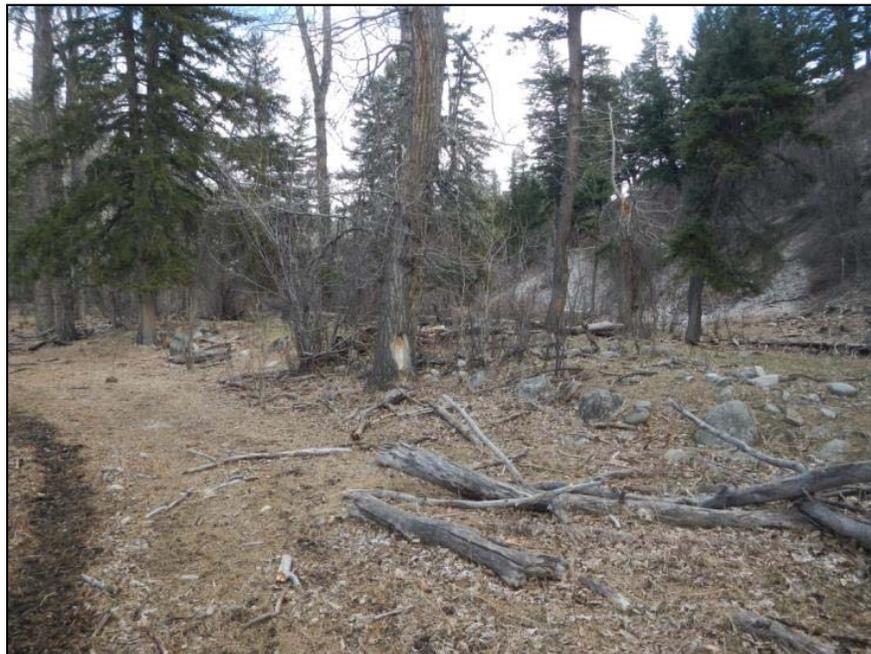
Channel Area” is out of the 100-floodplain and separated from the South Channel by a “Natural Floodplain Berm” which is probably a glacial moraine remnant from the mouth of Horseman Creek (see Figure 8).

Figure 8. View down valley (east) showing coarse floodplain berm separating secondary South Channel (behind photographer) and potential avulsion site in distance.

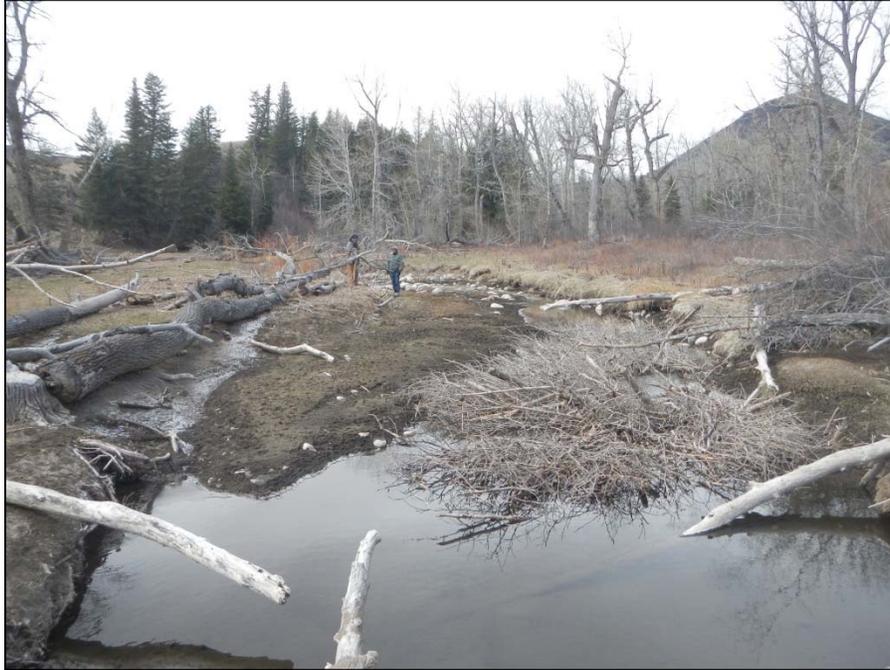
Another means of increasing flows over the floodplain and into the historic channel is backwatering in the South Channel by beaver damming. At the time of our field investigation there was a large beaver dam remnant that had clearly backwatered much of the South Channel. Numerous beavers have been trapped out of this area and as a result backwatering is minimal (see Figure 9).

Figure 9. View upstream on lower end of South Channel showing the historic beaver dam impoundment.

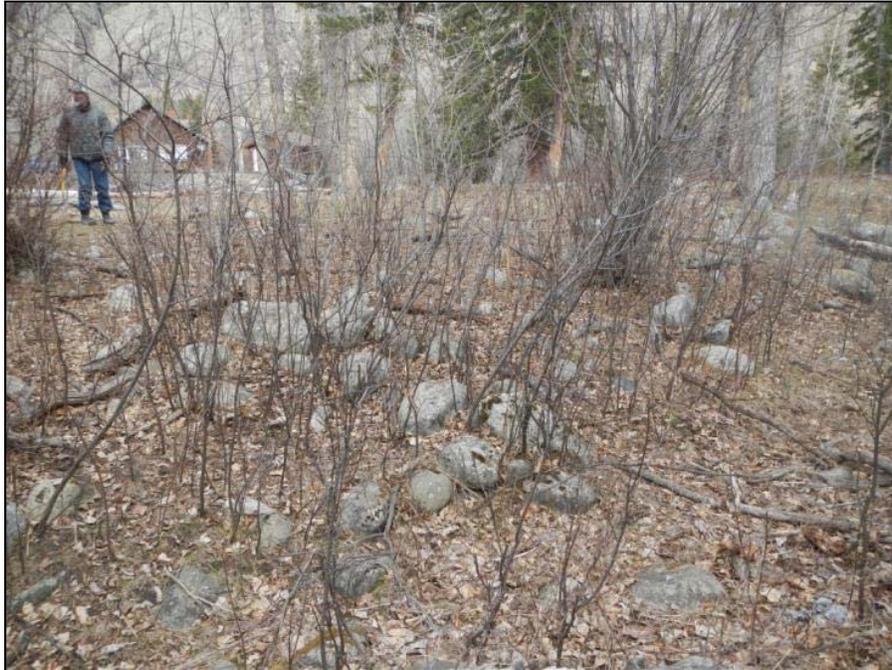
In the event the historic channel area is accessed by floodwater, it would take high energy flows to erode the existing material due to its coarseness. In general, one major characteristic of this site is coarse floodplain material, which adds natural resilience to avulsion (see Figure 10).

Figure 10. Floodplain roughness near potential avulsion site.

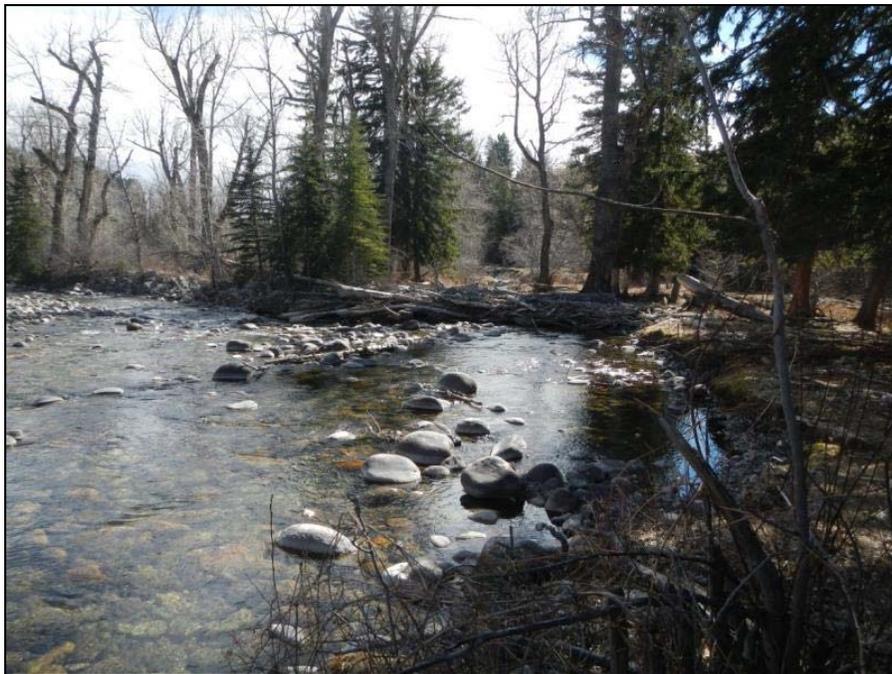
As described previously, there is currently a large debris jam blocking the entrance of the South Channel (see Figure 11). Just upstream of this debris jam, the right bank of the main North Channel has experienced some accelerated erosion due to the flanking of bank armor, which has made the entrance of the secondary South Channel more accessible to typical river flows. Alternative 3 would consist of reconstructing the right bank and installing flow deflectors to reduce access to the South Channel feature. The complete blockage of the secondary South Channel is not recommended due to its contribution to fish habitat and geomorphic complexity on the West Fork.

Figure 11. View downstream towards debris jam located at the secondary South Channel entrance (center of photo) showing right bank erosion and flanked large boulder riprap remnants in the Main Channel.

The estimated cost for Alternative 3 is approximately \$118,000.

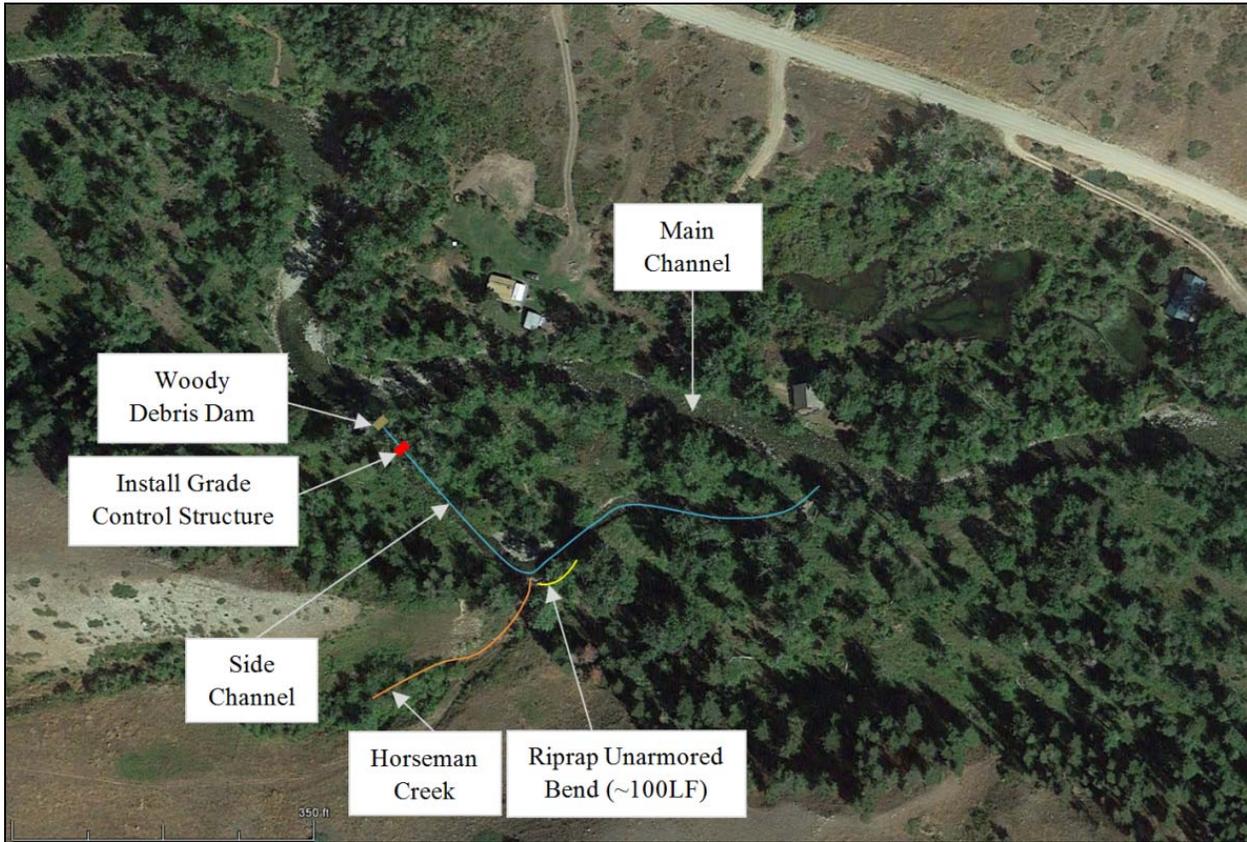
Figure 12. Proposed locations for a grade control structure and riprap, Alternative 4.

As enlargement of the secondary South Channel is a major concern with regard to increased avulsion potential, preventing additional enlargement and channel migration in the South Channel may be appropriate. Alternative 4 consists of installing a grade control structure in the bed of the South Channel and placing riprap along the eroding bend at the potential point of avulsion (see Figure 12). Schematic cross-sections for the grade control structure and riprap are shown on Figure 13 and Figure 14, respectively.

The estimated cost for Alternative 4 is approximately \$70,000.

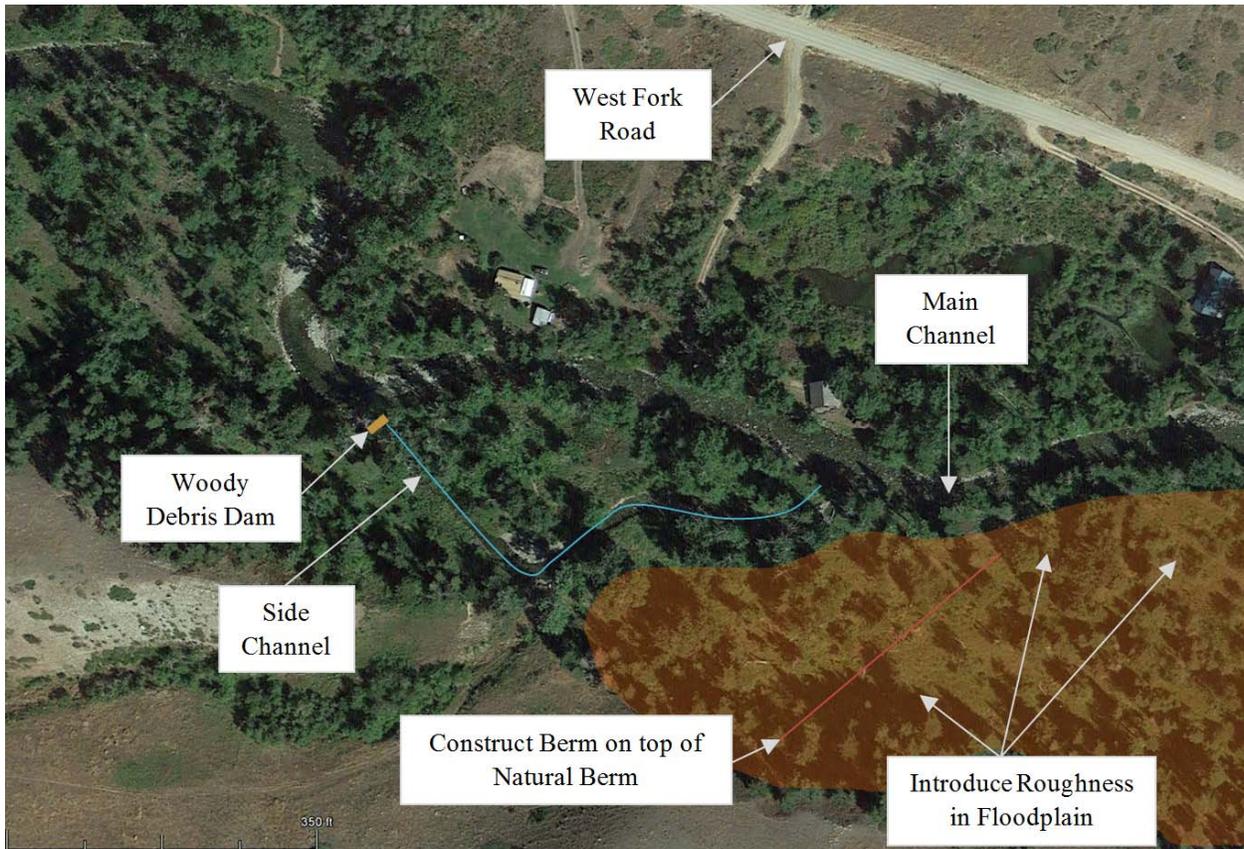
Figure 15. Proposed locations for a floodplain berm and roughness elements.

To reduce overbank flows into the historic channel and prevent floodplain erosion, Alternative 5 consists of installing a floodplain berm and incorporating floodplain roughness elements (see Figure 15). The proposed floodplain berm would be approximately 200 feet long and would be integrated with large woody debris to further dissuade floodplain erosion.

The estimated cost for Alternative 5 is approximately \$83,000.
