Lower Stillwater River Assessment

Prepared by:
Warren Kellogg
Stream & Watershed Consulting
38 Hidden Valley Drive, Clancy, MT 59634
January 2018

Stillwater Valley Watershed Council

January 2018

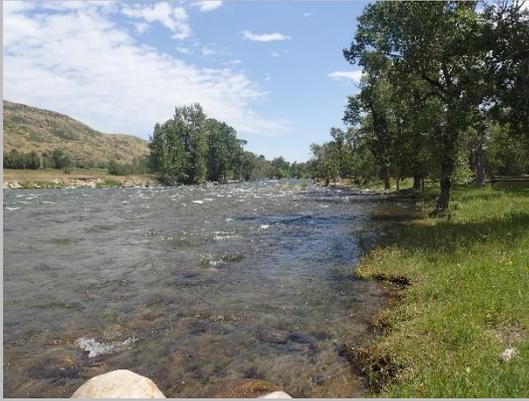
The river channel along Reach LSR1 is relatively straight with fast-moving riffles/runs and a cobble/gravel bottom.

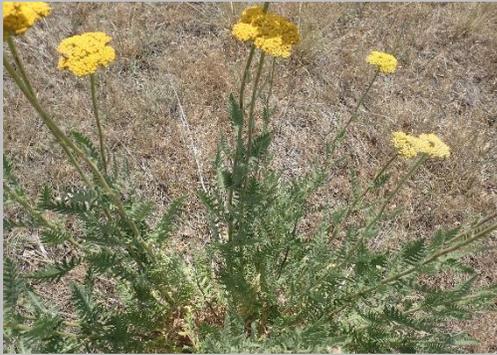
Common tansy is a noxious weed used as an ornamental on a subdivision tract.

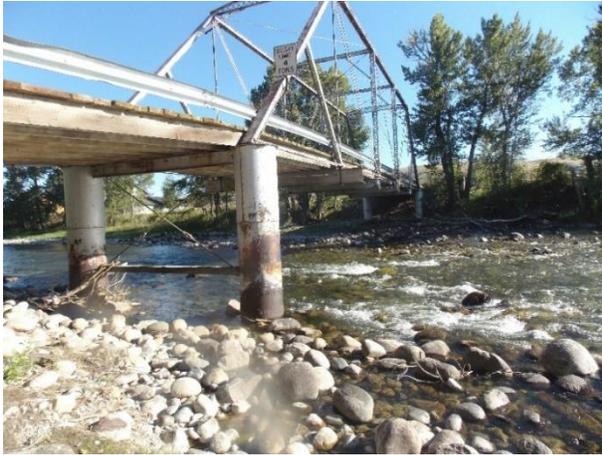
The Albert Johnson Bridge has recently been determined to be “structurally deficient” by the Montana Department of Transportation and is scheduled to be replaced in 2020 with a 155-foot long by 20-foot wide pony truss bridge. The new bridge will span the river without mid-channel supports. The Garrigus Ditch crossing under the county road will be replaced with a concrete box culvert.

The Albert Johnson Bridge is scheduled to be replaced in 2020. The old bridge will be offered for “adoption”. If there is no interest, it will likely be dismantled.

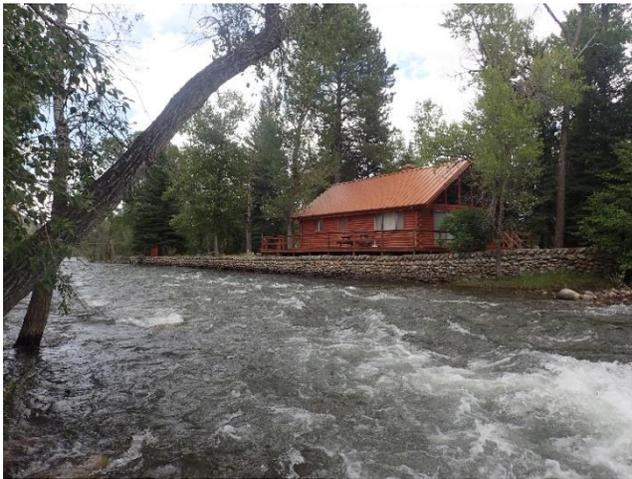
The subdivision was developed before 1975, prior to mandatory subdivision review. Approximately 625 feet of the north bank are impacted by the subdivision. Individual subdivision tract impacts to channel stability, in-stream flow, and water quality are usually small, but multiple small tracts in an older subdivision cumulatively pose a significant risk to the Stillwater River.

A house and rock retaining wall built on a mid-channel island is part of the Midnight Frolic Subdivision.

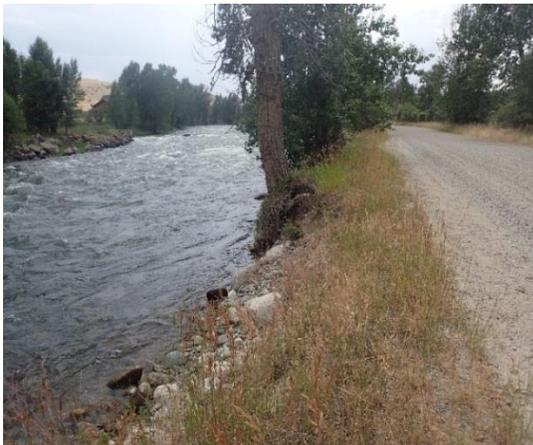
This section of the North Stillwater Road closely follows 970 feet of the north river bank. The edge of the road berm is less than 15 feet from the river, and in some cases, much closer. The river bank is subject to periodic ice jams and annual high water. Short segments of bank have been armored with rock and/or concrete chunks (poorly sized and spaced); other segments are currently stabilized by small trees/shrubs or left bare to erosion. Given the proximity of the road to the river, protecting the road and assuring public safety is an on-going concern for the Stillwater County Road Department and local landowners.

North Stillwater Road (Upper Section) closely parallels the river where eroding banks are threatening road integrity.

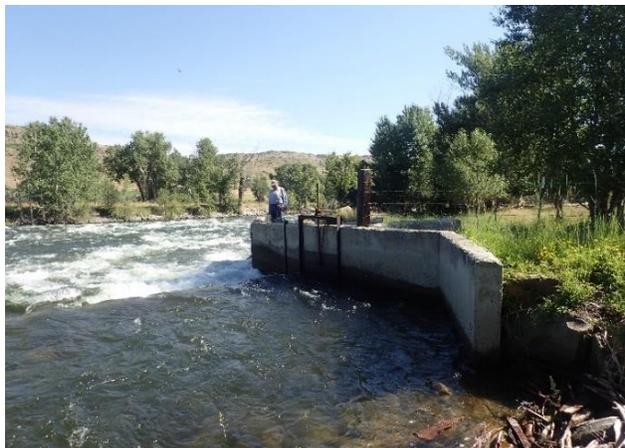
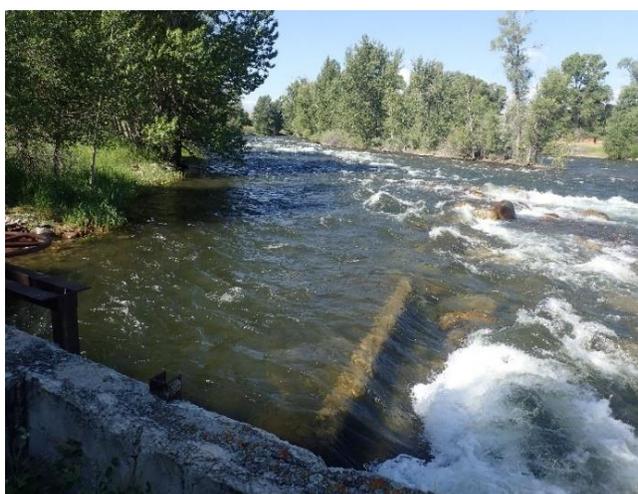
The irrigation system is not shown on the 1900 Government Land Office Survey Map; however, the 1946 Water Resources Survey map depicts the Benbow Ditch irrigation system with a point of diversion at its current location. “1970” inscribed on the headgate structure is likely the date when it was last replaced or repaired.

The Benbow Ditch Headgate diverted water to irrigated lands that have since been converted to small residential tracts.

The concrete sill and rock diversion associated with the old Benbow Ditch headgate can still be seen in the river.

Although the headgate is no longer used, removal is not recommended. The site is currently stable with minimal impact on the river. Any disturbance resulting from structure removal may accelerate bank and channel instability.

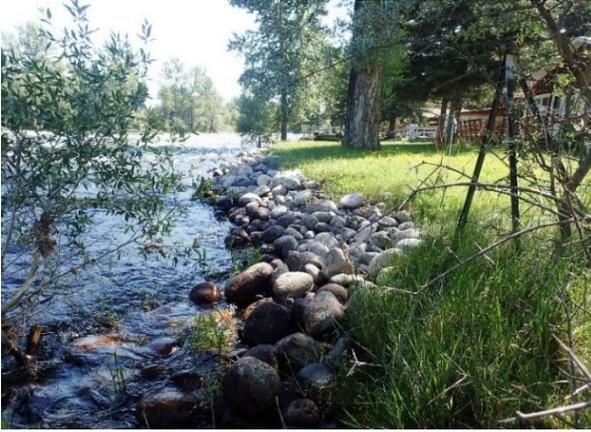
The subdivision was developed before 1975, prior to mandatory subdivision review. Approximately 650 feet of the south bank are impacted by this subdivision. Individual subdivision tract impacts to channel stability, in-stream flow, and water quality are usually minor, but multiple small tracts in a relatively old subdivision cumulatively pose a significant risk to the Stillwater River.

Fellows Subdivision is an old subdivision with tracts in the 100-year floodplain.

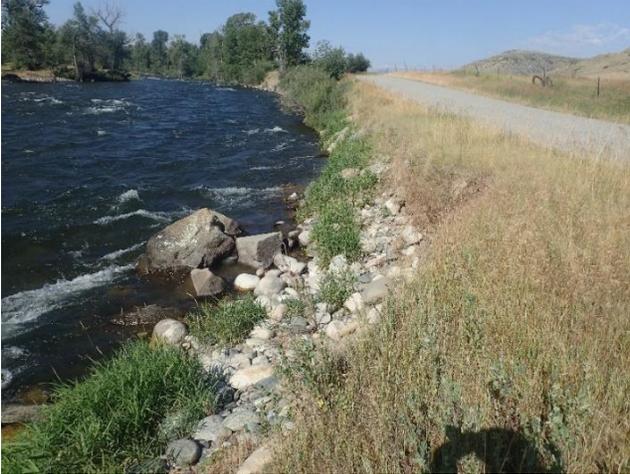
Site LSR-7 is comparable to Site LSR-4: Bank Erosion - North Stillwater Road (Upper Section). The middle section of the North Stillwater Road closely follows 1,400 feet of the north river bank. The edge of the road berm is often less than 10 feet from the river and as close as 2 feet. The river bank is sparsely armored with poorly sized and spaced rock and/or concrete rubble. Most bank armor has scoured out and/or sloughed down the steep bank subjecting the river bank and adjacent road to active erosion. Some concrete rubble has exposed rebar, creating a safety hazard. Brush has been piled on the bank at the lower end of the site. Small trees and shrubs growing along the toe of the bank have provided some stability to the river bank.

The existing rock rip-rap has sloughed down into the channel making the river bank and road vulnerable to erosion.

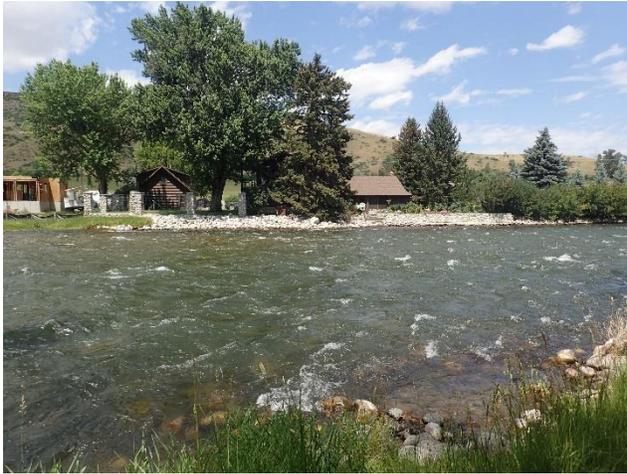
Individual subdivision tract impacts to channel stability, in-stream flow, and water quality are usually minor, but multiple small tracts in a relatively old subdivision cumulatively pose a long-term risk to the Stillwater River.

Retaining walls, bank armor, and floodplain dikes have been installed to shield subdivision tracts from river migration and flooding.

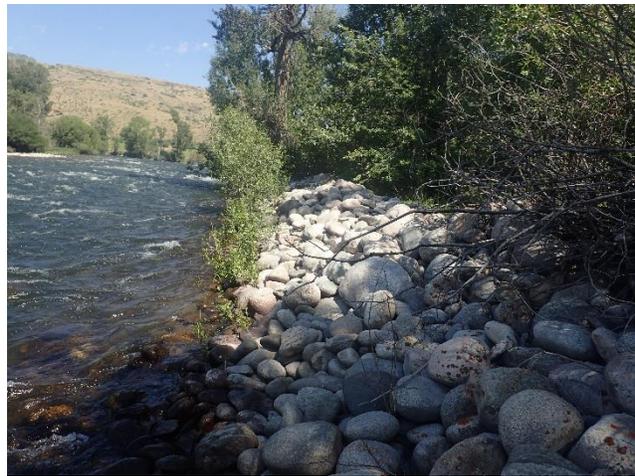
Rock rip-rap and a cobble dike on the lower end of Site LSR-10 are preventing high flows from accessing the historic floodplain.

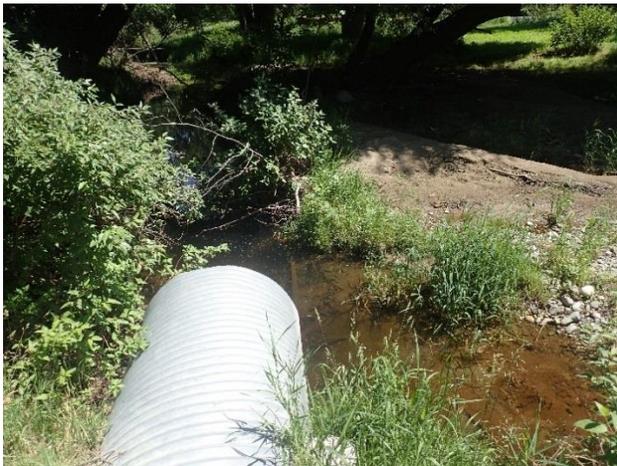
The corral system is located on the north side of the North Stillwater Road. The county road lies between the corral and the river. A drain ditch diverts run-off and irrigation return flows out of the corrals, through a road culvert and directly to the river. Elevated levels of nutrients from the corrals are likely reaching the river.

Irrigation waste water and surface runoff from corrals pass through a county road culvert to the river.

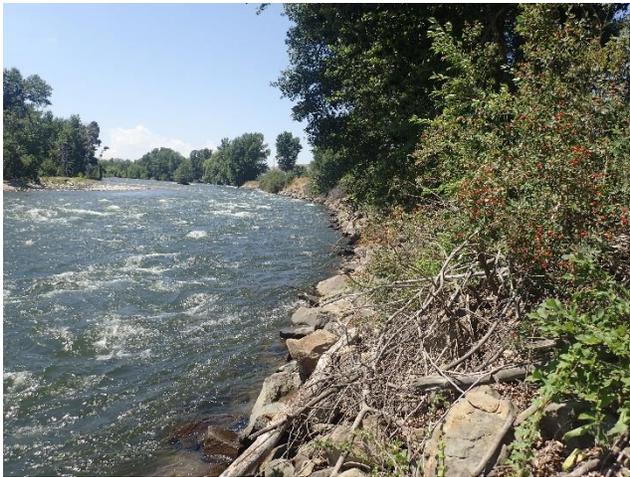
On the north side of the county road, NorthWestern Energy operates a natural gas compressor station designated Absarokee Compressor Station #054-1. The station, formerly owned by the Montana Power Company has been in operation for over 65 years. Associated with the compressor station is a concrete sump embedded in the rock rip-rap that provides water to the facility. On the lower end of the site, a gas transmission pipeline crosses beneath the river. The pipeline's age, depth below the river bottom, and type of material is unknown.

Rock rip-rap placed between the river and the North Stillwater Road.

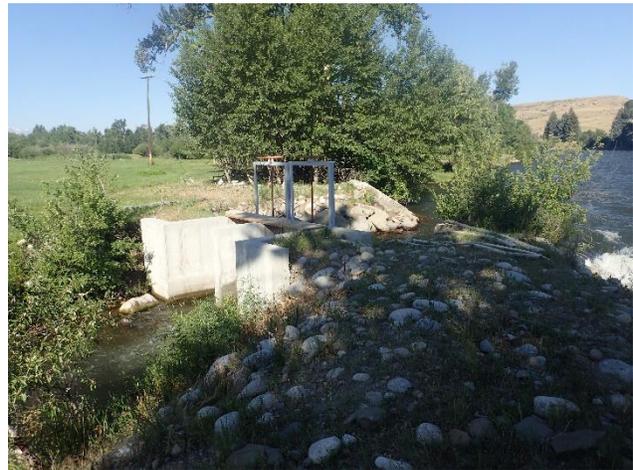
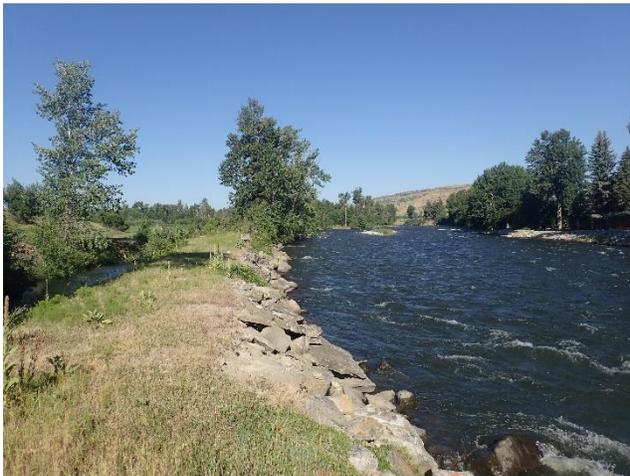
The Roadhouse Ditch headgate is located on the south river bank. The headgate has been recently replaced with a concrete structure and two slide gates, placed ~20 feet into the ditch. Remnants of the previous structure can be seen in front of the headgate. A large rock diversion extends ~ 50 feet into the channel at a 45° upstream angle towards a mid-channel gravel bar.

The Roadhouse Ditch headgate was recently replaced with a concrete structure and slide gates.

Downstream from the Roadhouse headgate, a large dike faced with rock rip-rap prevents the river from breaching into the Roadhouse Ditch.

The Roadhouse Ditch irrigation system is over 120 years old. A comprehensive system-wide evaluation of water conveyance efficiency, infrastructure condition and functionality, fish entrainment, and noxious weed mapping would serve as the basis for a long-term capital improvement plan that would provide prioritization and scheduling of system improvements.

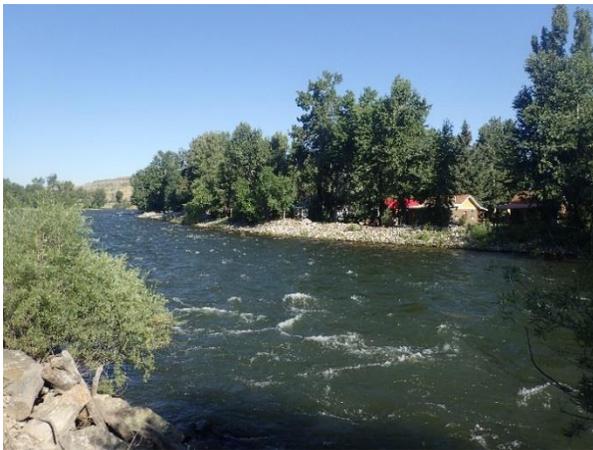
Individual subdivision tract impacts to channel stability, in-stream flow, and water quality are usually minor, but multiple small tracts in a relatively old subdivision cumulatively pose a significant risk to the Stillwater River.

Nearly all the Riverside Subdivision tracts have cobble rip-rap and dikes lining the river bank.

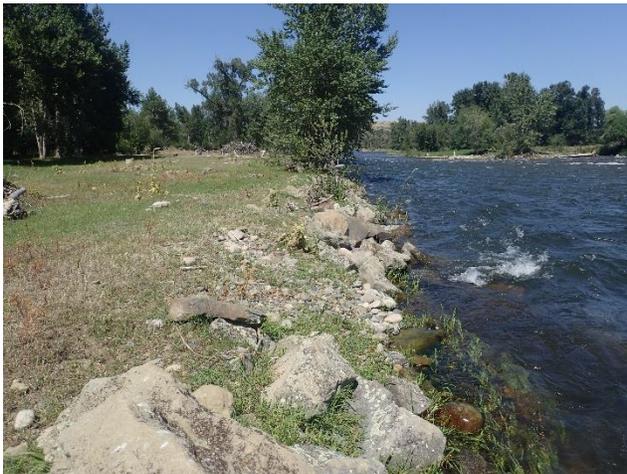
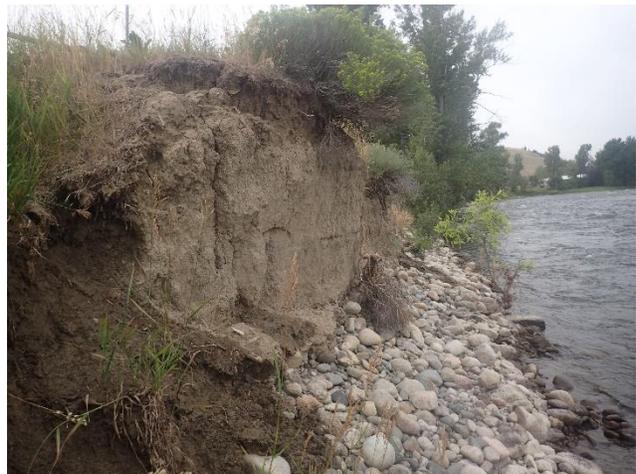
West Bank: Old rock rip-rap and a cobble dike line ~ 700 feet of river bank east of the Scollard buildings. During the winter of 2017, ice jams caused out-of-bank flooding on the west bank.

East Bank: The hay field next to the river is flood irrigated causing the river bank to become saturated. When saturated, sections of river bank actively slough. Small head cuts and scars from over-bank irrigation return flows are also evident. Despite the active sloughing, the river bank has receded very little over the last 20 years.

West Bank: Old rock rip-rap lines the river bank along a horse pasture.

East Bank: Sloughing of the bank is caused by irrigation-induced saturation.

- 2) Excessive water infiltration and bank saturation would be significantly reduced by converting the existing flood irrigation system to sprinkler irrigation. The Columbus NRCS Office or local sprinkler dealer could help evaluate the feasibility and cost effectiveness of this option.

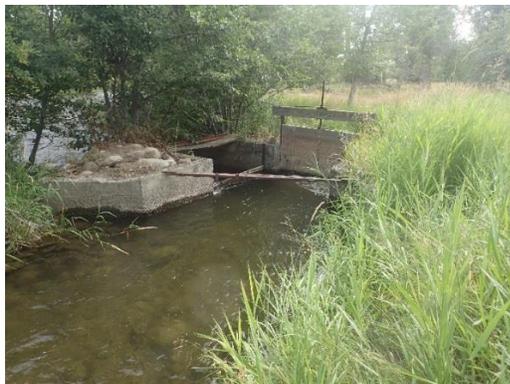
The Nichols Ditch headgate is located on a secondary channel that loops south of the Stillwater River mainstem. The headgate is an old concrete structure reinforced with steel braces. The amount of water entering the headgate is controlled using a wood slide gate and a check structure with removable boards. The structure is in good condition with slight scouring under the wall footings. The headgate is set 165 feet down-ditch from the channel. Cobble diversions are periodically used in both the mainstem and secondary channel to direct late season flow towards the headgate.

The Nichols Ditch headgate is an old concrete structure that still functions well.

The Nichols Ditch irrigation system is over 100 years old. A comprehensive system-wide evaluation of water conveyance efficiency, infrastructure condition and functionality, fish entrainment, and noxious weed mapping would serve as the basis for a long-term capital improvement plan that would provide prioritization and scheduling of system improvements.

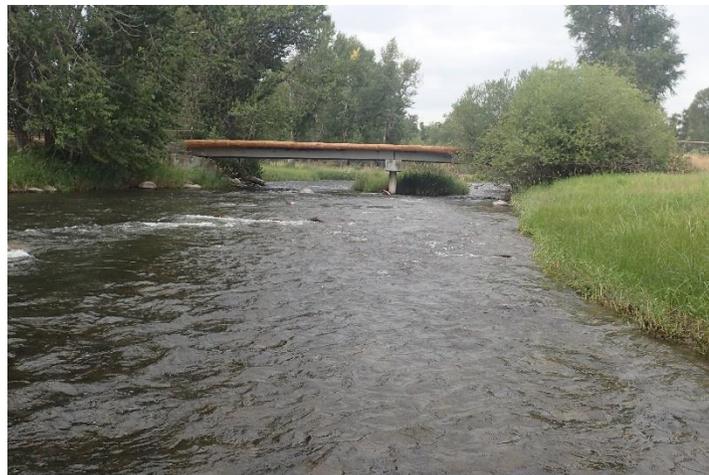
The mid-channel bridge support has created an upstream sediment bar.

When the bridge is eventually replaced, the new bridge should span the channel without the need for a mid-channel support.

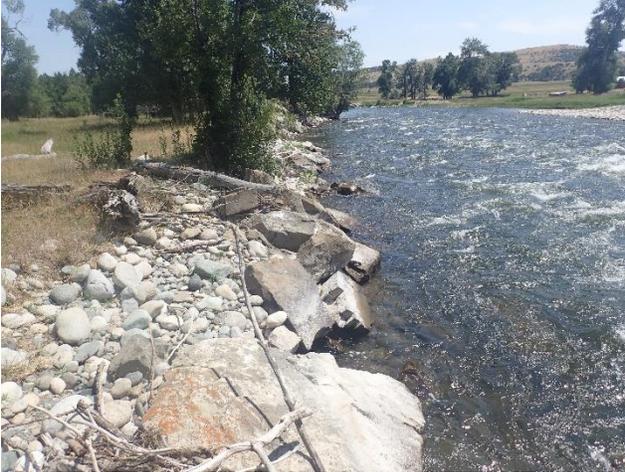
Site K-north river bank: ~ 570 feet of rock rip-rap is located across the river from the mouth of the secondary channel. The rip-rap includes large rock intermittently placed along the river bank on a straight reach of river. Minor bank scouring and rock sloughing have occurred.

Rock rip-rap has been intermittently placed along a naturally stable cobble bank.

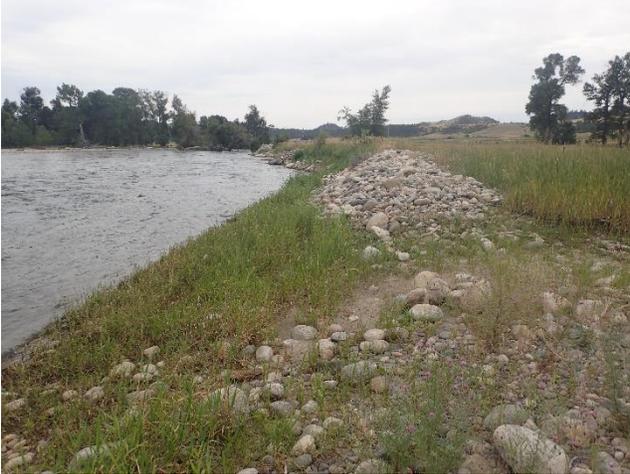
North Bank: An old cobble dike, 340 feet long, was constructed on an inside bend across from Site LSR-21. Further downstream on the braided section, the river has migrated ~ 70 feet north over the last 40 years, prompting the landowner to move a ranch road and armor 630 feet of a low terrace river bank with rock rip-rap.

Cobble dike piled on top of the river bank prevents high water access to the historic floodplain.

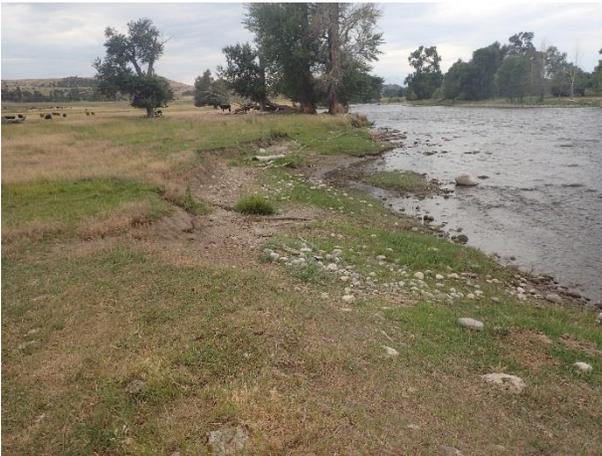
On the downstream bend, the channel becomes braided. Within the last 40 years, the main channel has directed more erosive flows toward the south river bank.

The river bank is actively eroding due to heavy livestock use and an absence of riparian vegetation.

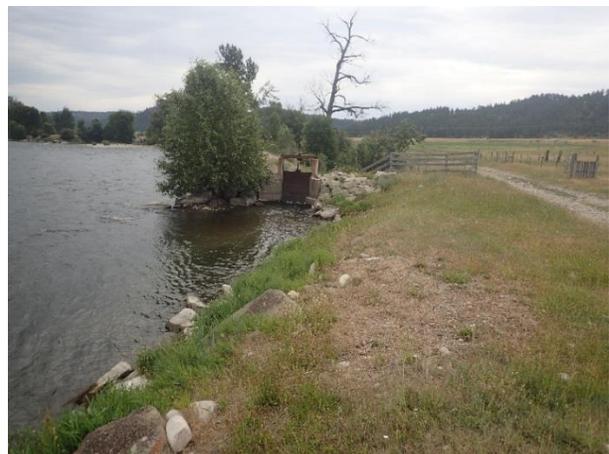
The Whitebird Ditch headgate is on the south river bank. The headgate is an old concrete structure with a metal slide gate. It is in good condition with minor scouring under the wall footings. The structure was placed ~50 feet off the river channel. Woody debris and sediment may collect in front of the headgate and need to be periodically removed.

The Whitebird Ditch headgate set into the south river bank.

The Whitebird Ditch irrigation system is nearly 120 years old. A comprehensive system-wide evaluation of water conveyance efficiency, infrastructure condition and functionality, fish entrainment, and noxious weed mapping would serve as the basis for a long-term capital improvement plan that would provide prioritization and scheduling of system improvements.

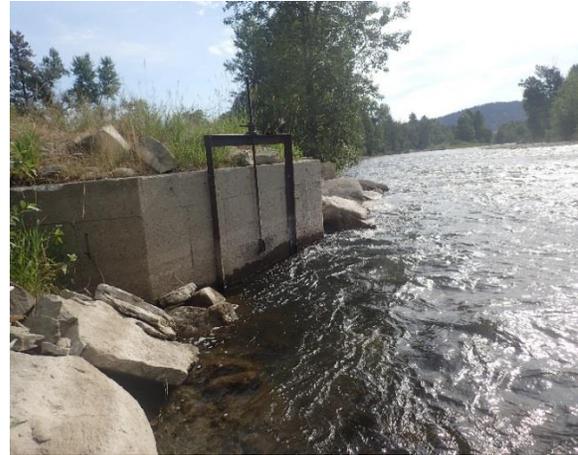
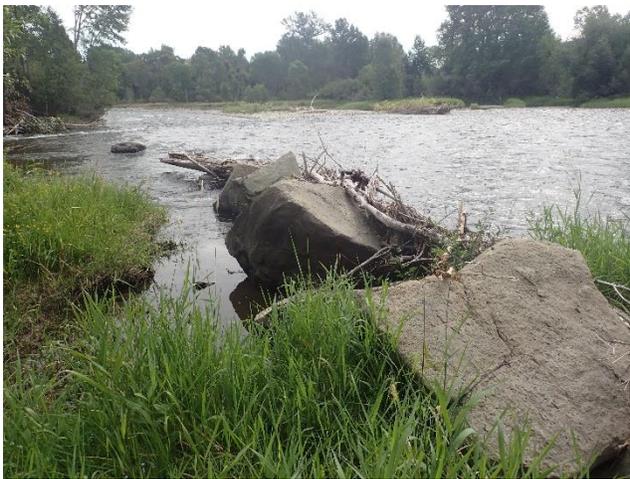
The Brown Ditch headgate sits on the north bank along a braided section of river. The headgate is a concrete structure with a metal slide gate. The gate leaks, but overall, the structure is in relatively good condition. The irrigation system is used by a single water-user. Outside the irrigation season, ditch water is used for livestock and is diverted into a series of small ponds on the lower end of Norve Coulee.

An old flow deflector partially diverts late summer flows away from a secondary channel that conveys water to the Brown Ditch Headgate.

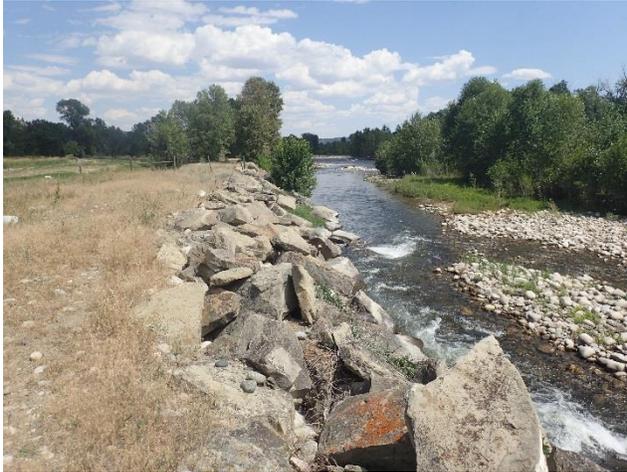
A large floodplain dike blocks a historic flood channel.

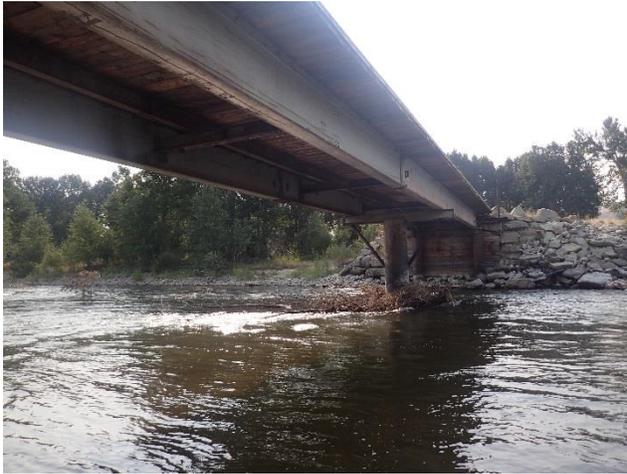
A private bridge with a mid-channel support spans the Stillwater River mainstem.

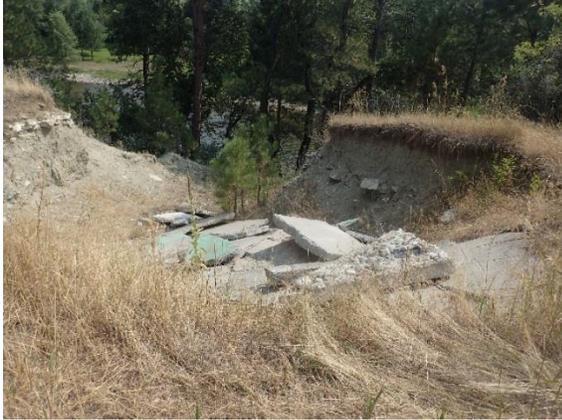
Concrete slabs dumped in an irrigation wash-out intended to prevent further erosion.

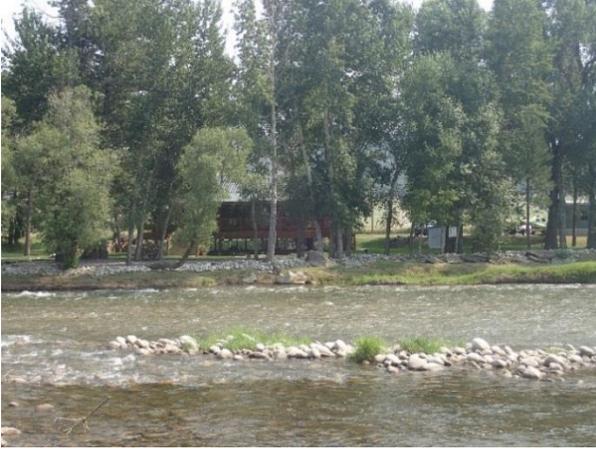
The Sutherland Subdivision tracts lie within the 100-year floodplain making them vulnerable to flooding.

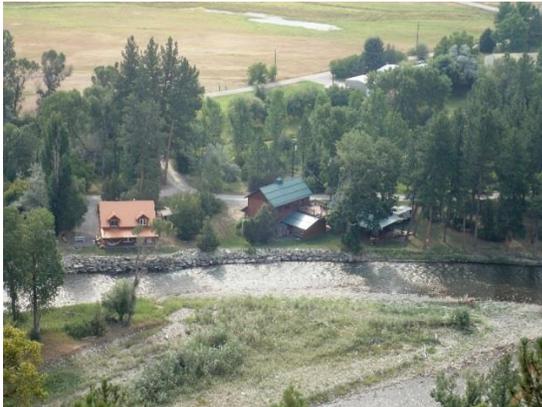
Most development in the Dolan Subdivision lies within the 100-year floodplain and close to the river's edge.

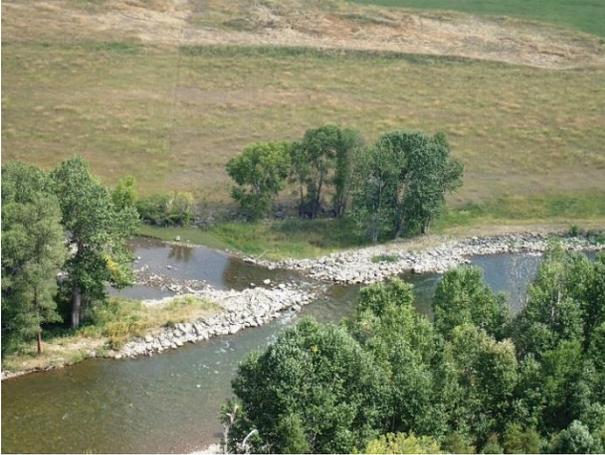
The rock chute at the entrance of the secondary channel limits flow to the White Ditch headgate.

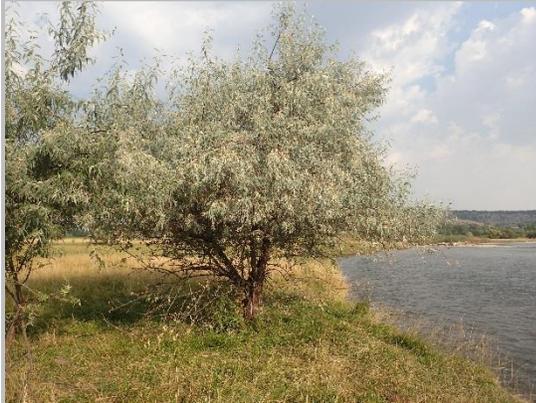
Russian olive trees are common along the Yellowstone River. These invasive plants are beginning to move up the Stillwater River. It is highly recommended that they be eradicated while it is still economically feasible to do so.

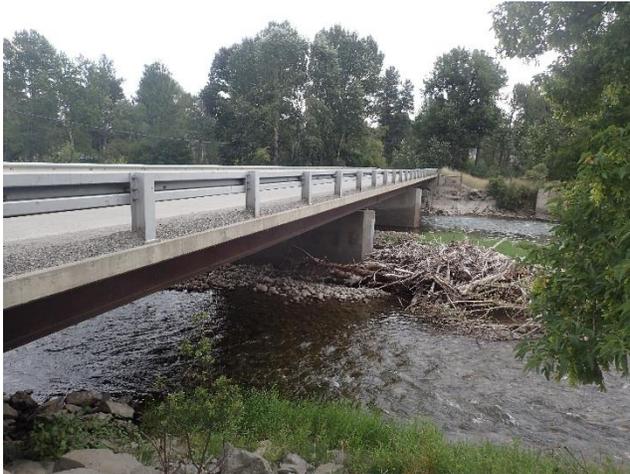
Countryman Creek Road Bridge has mid-channel supports that catch woody debris. A large gravel bar has formed on the downstream side of the bridge.

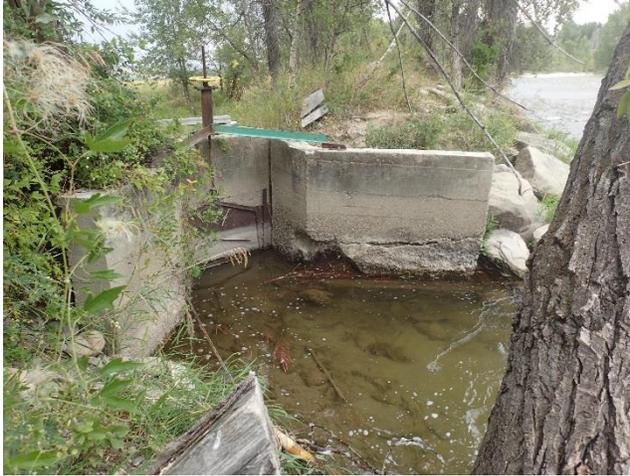
The headgate is in poor condition and should be replaced in the near future.

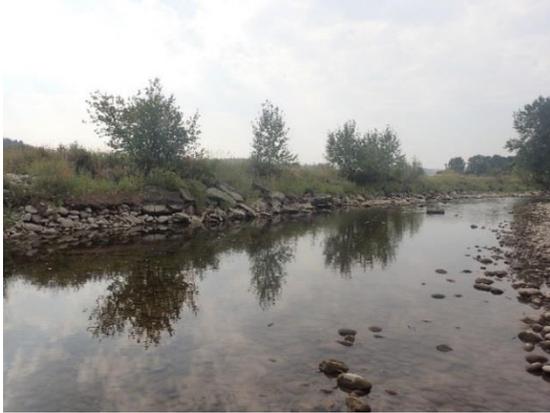
Old rock rip-rap lines the east bank of the secondary channel.

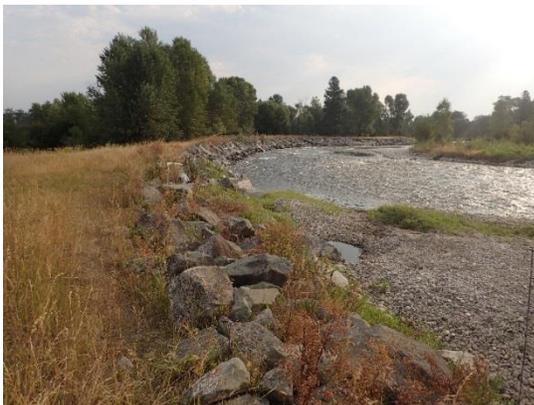
A large dike faced with rock rip-rap prevents high-water from accessing historic flood channels.
