Stillwater River Flood Rehabilitation River Assessment Triage Team (RATT) 2023 Summary Report Prepared for:

## Stillwater Valley Watershed Council

Karin Boyd Applied Geomorphology, Inc.

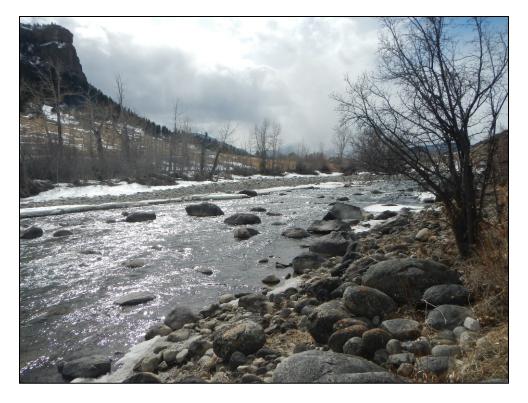
#### Figure 7. Large boulders in bed material, Stillwater River below Nye.

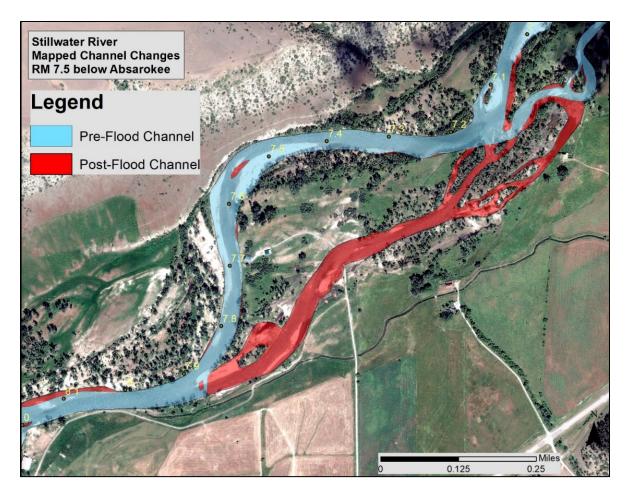
Figure 42. New channel formation at RM 7.5 below Absarokee showing extensive flood-induced erosion.

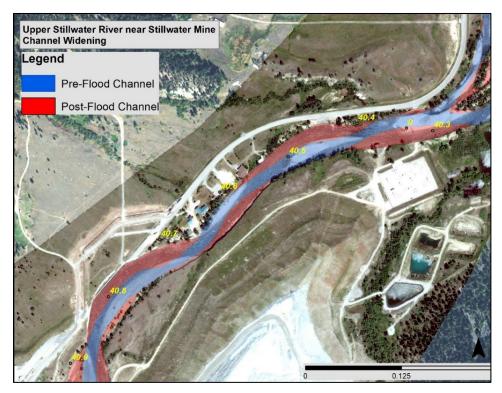
Figure 46. Channel widening due to flood erosion on upper Stillwater above Nye; the river doubled its width in several areas, destroying several structures. Channel widening also affected proximity of river to mine waste rock dump.

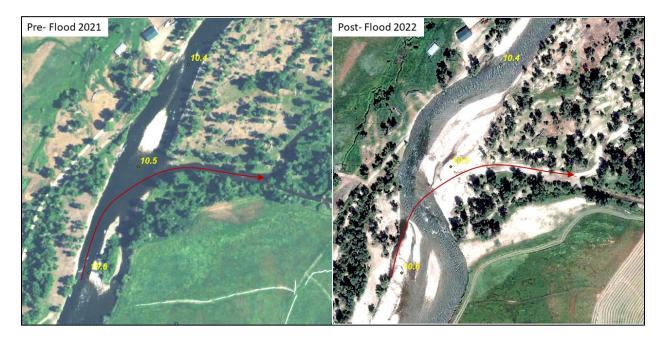
Figure 49. Large point bar deposition and loss of side channel connectivity on Stillwater River, RM 10.5.

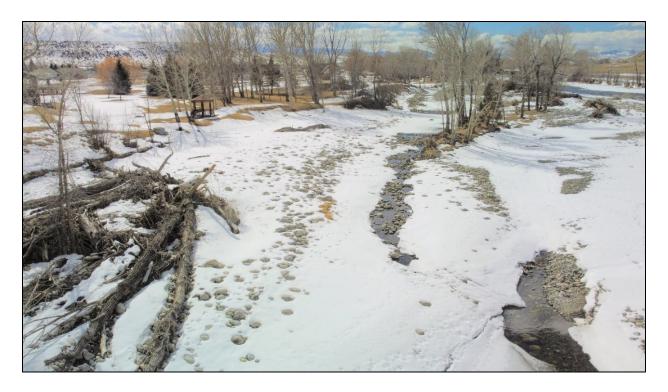
Figure 50. View upstream of an aggraded side channel (main channel is on upper right edge of photo) Stillwater River near RM 13.5.

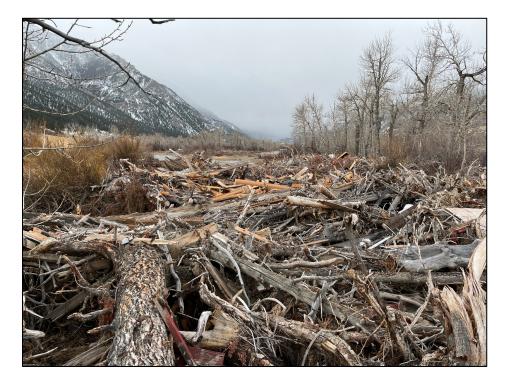
Figure 52. Example debris accumulation on upper Stillwater.

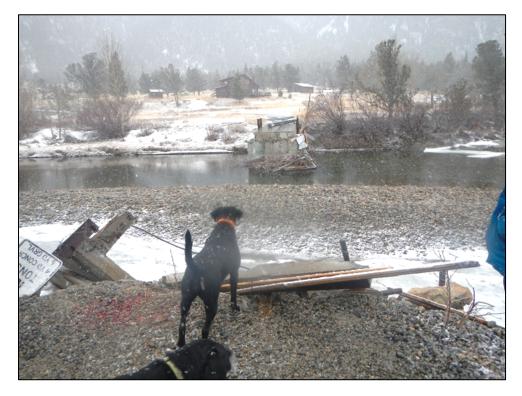
Figure 54. Upper Stillwater Bridge failure (RM 39.3); bridge provided the primary access route for the Rainbow Ranch Subdivision.

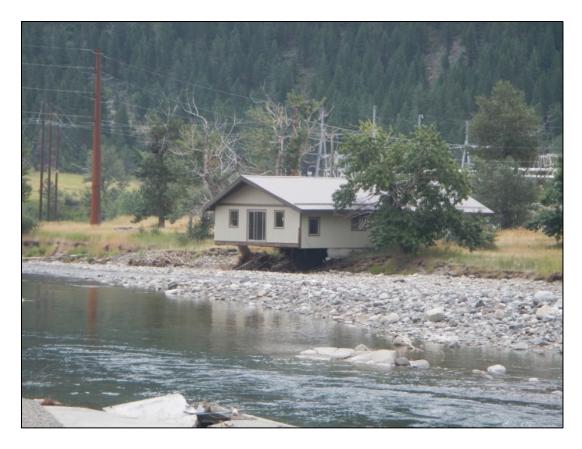
Figure 56. Undermined structure on Stillwater River upstream of Nye as viewed in late August 2022.

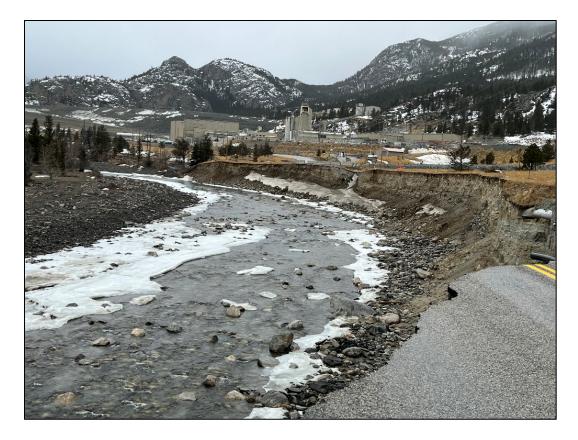
Figure 57. Road damage on upper Stillwater River near the Sibanye-Stillwater Mine (March 2023).

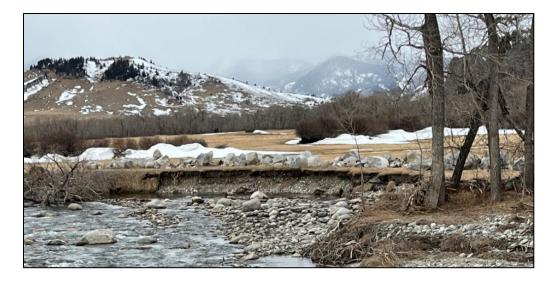
Figure 66. Large riprap staged on bankline; note lack of infrastructure threat and relatively passive bank margin post-flood.

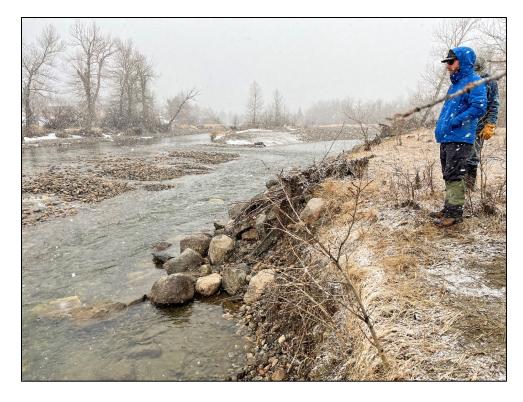
Figure 68. View upstream of local erosion on end of riprap; local use of wood can effectively deflect flows from bankline of concern and provide habitat.

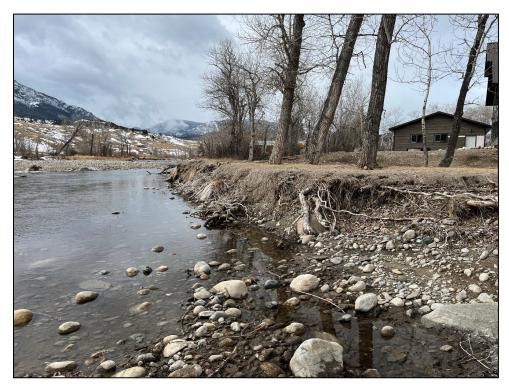
Figure 69. Localized erosion where homes are set back some distance from channel. This situation would warrant monitoring.

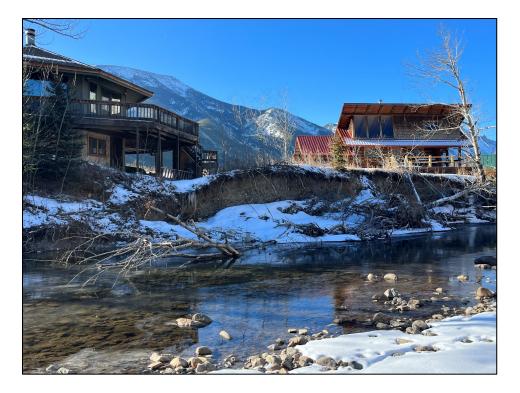
Figure 73. High terrace erosion in which achieving a 2:1 bank angle is problematic. Erosion control here will be best achieved with woody treatments and maintenance.

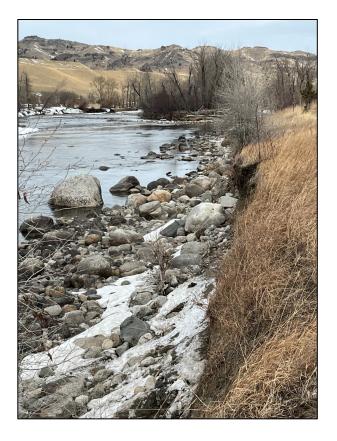
Figure 74. Coarse native boulder toe accumulations provide natural armor, no action recommended.

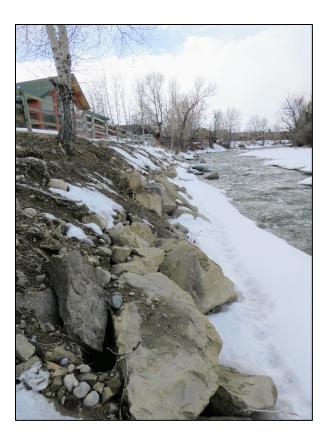
Figure 76. Steep bankline that was repaired under emergency status due to threat to property. This type of project can deteriorate and may not survive subsequent runoff events.

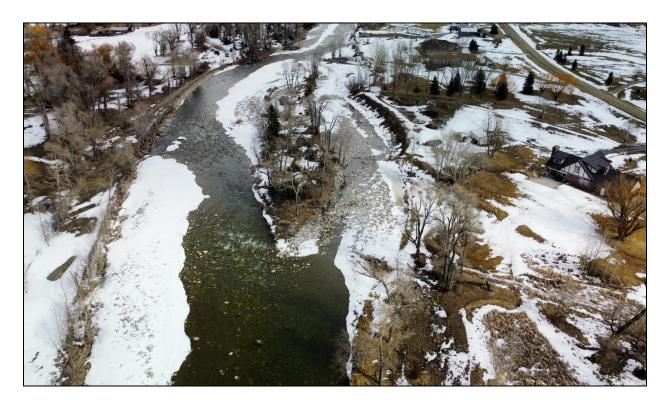
Figure 78. View downstream showing new deposition in Stillwater River side channel (on right) near Absarokee.

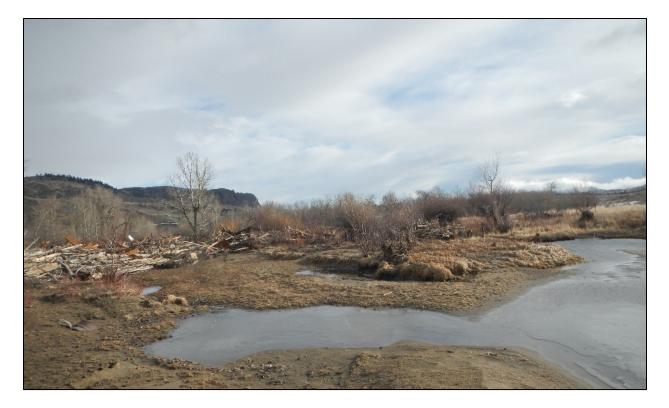
Figure 79. Floodplain wood accumulations that have altered typical floodplain flow paths, putting structures in jeopardy.

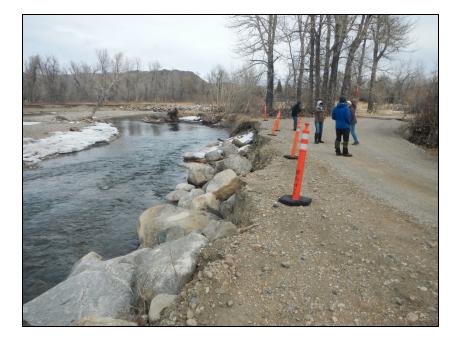
Figure 80. Flood damaged gravel access road margin on upper Stillwater River; this rock is on an over-steepened bank which will need to be regraded to remain stable.

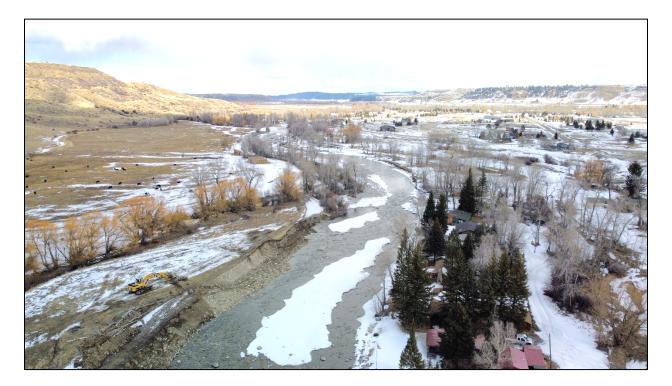
Figure 81. Downstream view of North Stillwater Road undergoing repair near Absaroka Fishing Access.

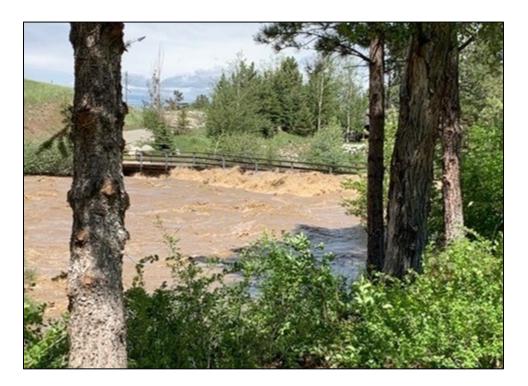
Figure 82. Private bridge along the Stillwater Road overtopping during flood (courtesy of Staci Grimm).

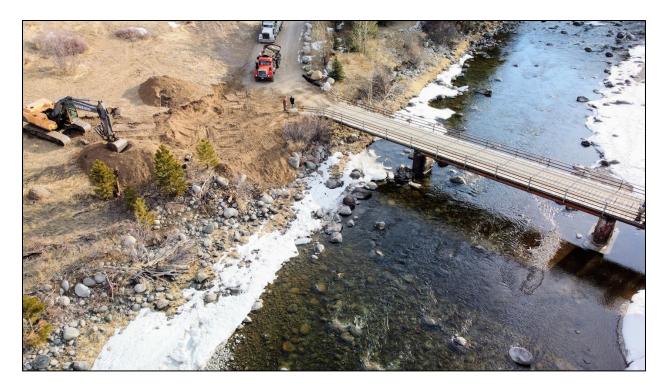
Figure 83. Active bridge abutment riprap reinforcement, Stillwater River.

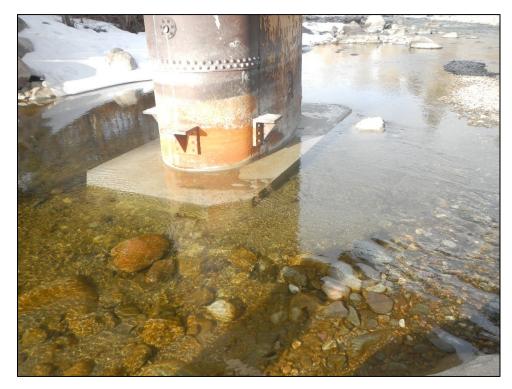
Figure 84. Bridge pier above Cliff Swallow FAS replacing one that was undermined during flood event, causing bridge to deck to buckle but not fail.

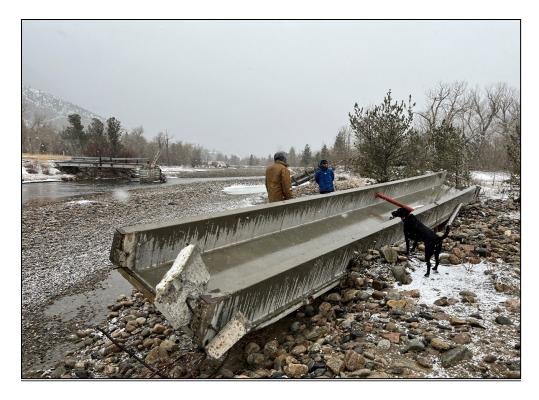
Figure 85. View upstream of failed bridge debris lodged on channel margin, Rainbow Subdivision bridge, upper Stillwater River.

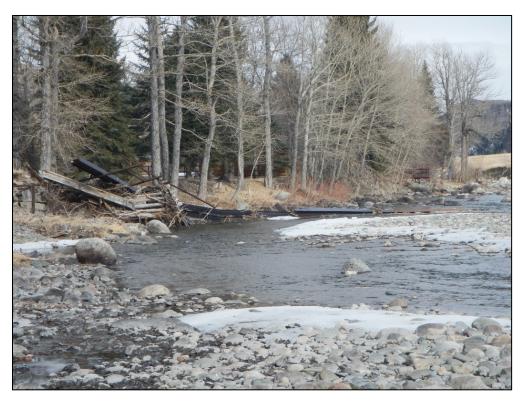
Figure 86. Small access bridge debris within active channel, middle Stillwater River.

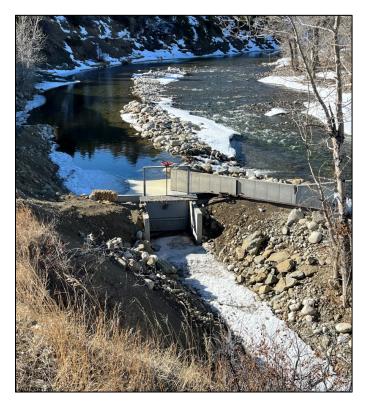
Figure 88. View upstream of Yanzik Diversion that experienced major abutment erosion during flood.

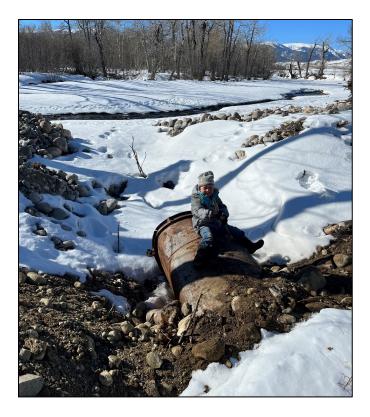
Figure 89. Diversion intake that experienced erosion damage; the bank was rebuilt with a cobble berm.

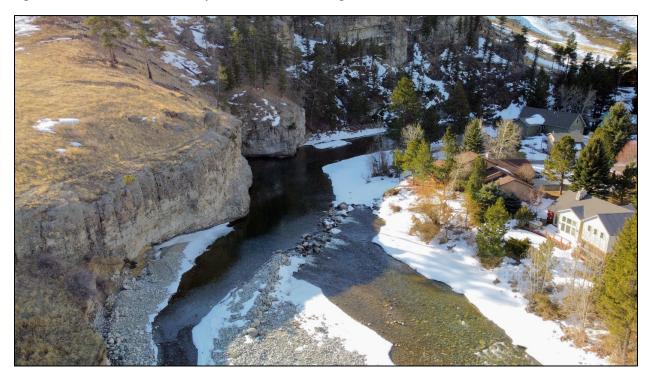
Figure 90. View upstream of rock diversion on the Stillwater River above Cliff Swallow spanning the entire channel. This diversion channel could be narrowed and extended upstream closer to the bedrock bank which would maintain flow and bedload transport capacity in the main channel.

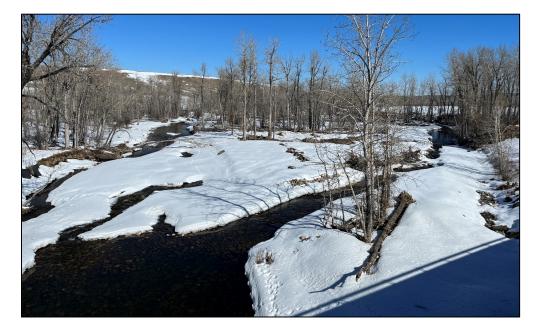
Figure 91. View downstream showing new channel formed via avulsion below the Highway 78 Bridge; note increased habitat and in-stream complexity provided by the two channels.

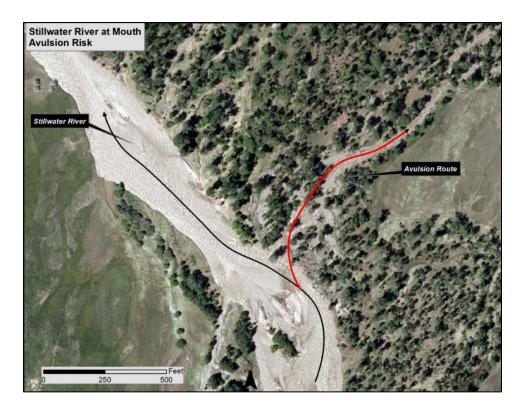
Figure 92. High flow image of avulsion node (breakout point) on outside bend, Stillwater River near mouth.

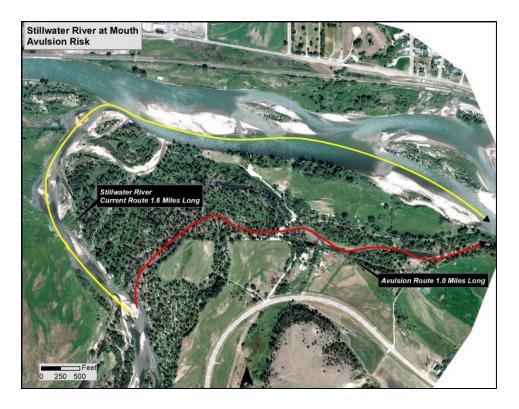
Figure 93. The risk of avulsion at this site (red line) will persist due to the more efficient (shorter and steeper) route of the avulsion path relative to the current path. It should be closely monitored during the 2023 runoff season.
