Memorandum

To: Lindsey Clark, Stillwater Valley Watershed Council Coordinator
From: Chad Raisland, Pioneer Technical Services, Inc. and Karin Boyd, Applied Geomorphology, Inc.
CC: Tanya Lester, Stillwater Conservation District Administrator
Date: 8/2/2016
Re: West Fork Stillwater River Avulsion Assessment

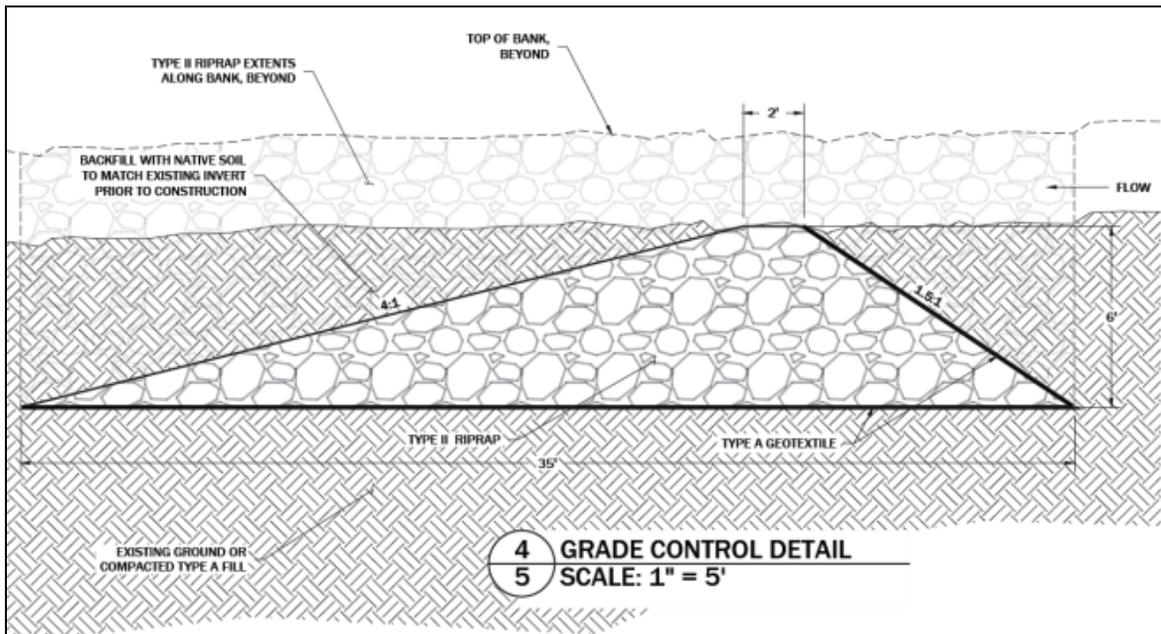
Figure 13. Schematic cross-section of the proposed South Channel grade control structure.

As enlargement of the secondary South Channel is a major concern with regard to increased avulsion potential, preventing additional enlargement and channel migration in the South Channel may be appropriate. Alternative 4 consists of installing a grade control structure in the bed of the South Channel and placing riprap along the eroding bend at the potential point of avulsion (see Figure 12). Schematic cross-sections for the grade control structure and riprap are shown on Figure 13 and Figure 14, respectively.

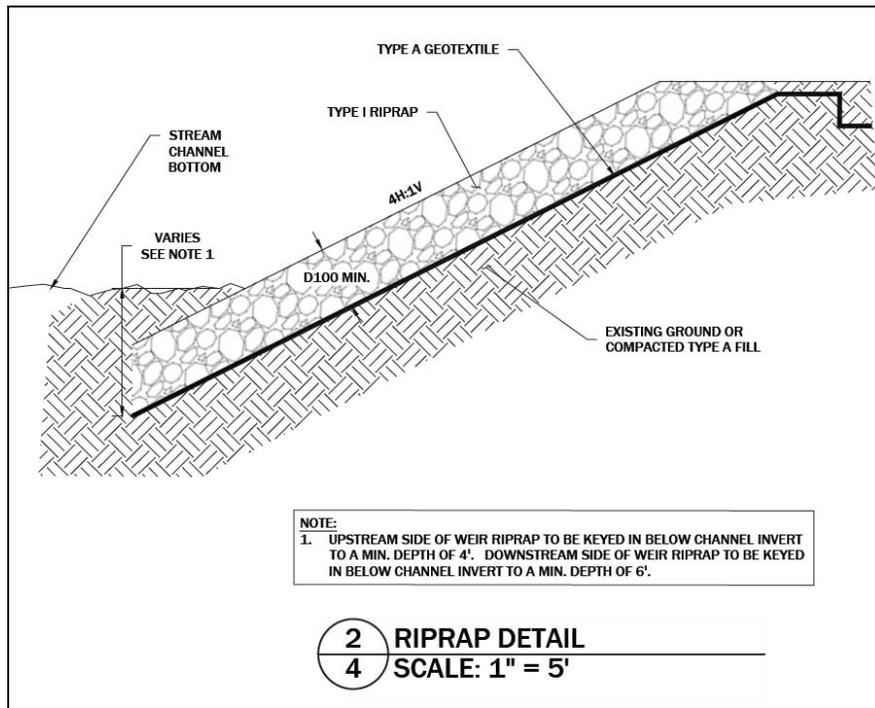
Figure 14. Schematic cross- section of the proposed South Channel riprap.
