Lower Stillwater River Assessment

Prepared by:
Warren Kellogg
Stream & Watershed Consulting
38 Hidden Valley Drive, Clancy, MT 59634
January 2018

Stillwater Valley Watershed Council

January 2018

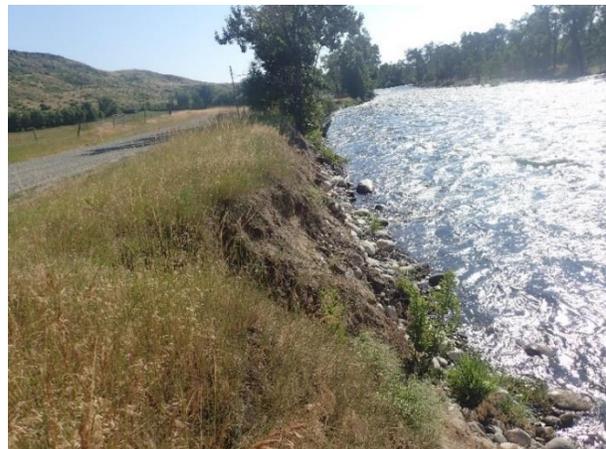
The river bank along the North Stillwater Road is actively eroding due to periodic ice jams and early summer high flows.

The existing rock rip-rap has sloughed down into the channel making the river bank and road vulnerable to erosion.

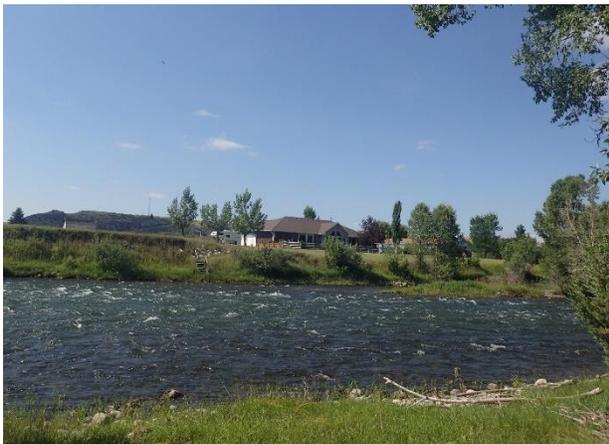
Circle T Subdivision tracts are located on a low terrace above the river.

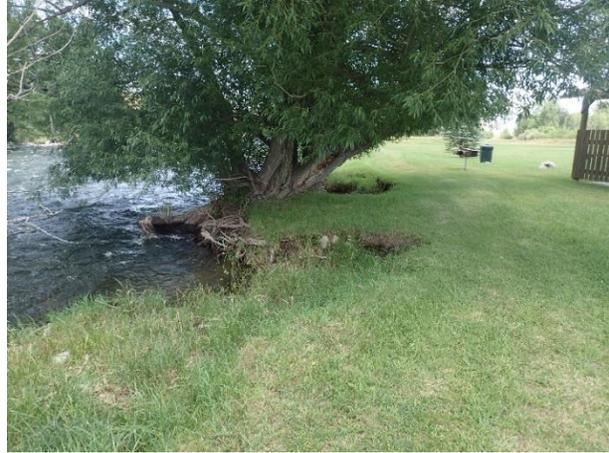
Establishing a riparian buffer along the upper end of the Circle T Subdivision Home Owners Assn. Park would stabilize the eroding river bank.

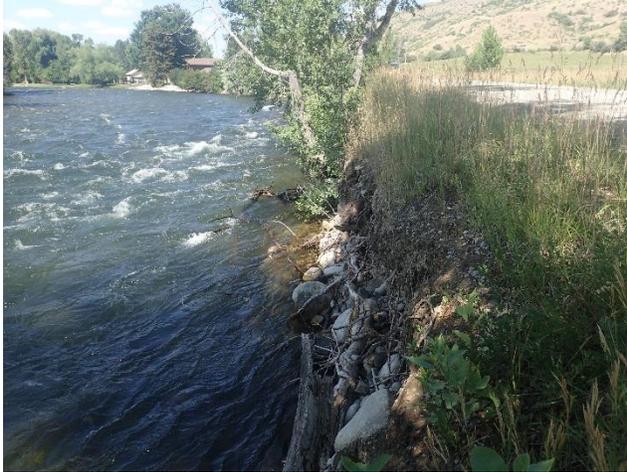
The river bank is actively eroding along the North Stillwater Road.

Rock rip-rap and a cobble dike on the lower end of Site LSR-10 are preventing high flows from accessing the historic floodplain.

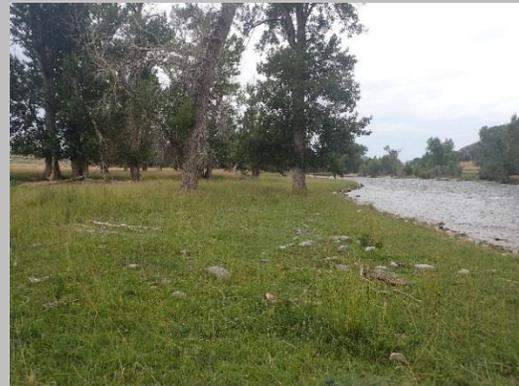
The riparian forest is generally in good condition with two exceptions: small pens where livestock is concentrated, and larger riparian pastures being damaged by unmanaged livestock use. Both situations hinder new shrub/tree growth and promote river bank instability.

An open black cottonwood riparian corridor without understory vegetation is not be sustainable.

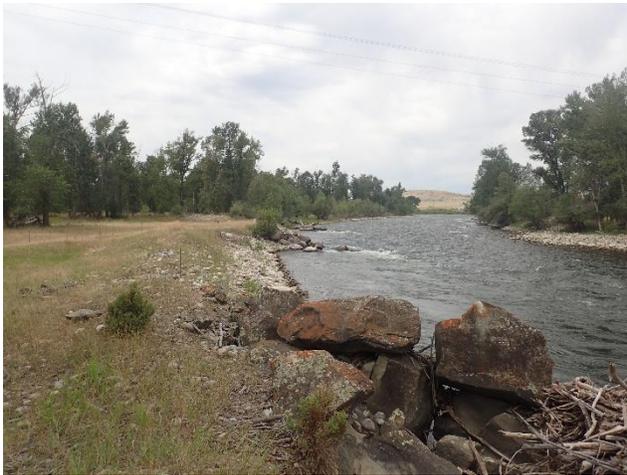
Site E-south river bank: 4 large rock flow deflectors (jetties) are spaced along 440 feet of an outside bend. The deflectors extend off a floodplain dike described at Site D. The deflectors point downstream at a 45° angle. Some bank scouring has occurred on the downstream side of each deflector due to backwater eddies. They were installed prior to 1975, possibly to prevent the river from migrating into the adjacent hay field. The deflectors appear to be working as intended.

Large rock flow deflectors (jetties) are causing backwater eddies that result in bank scouring.

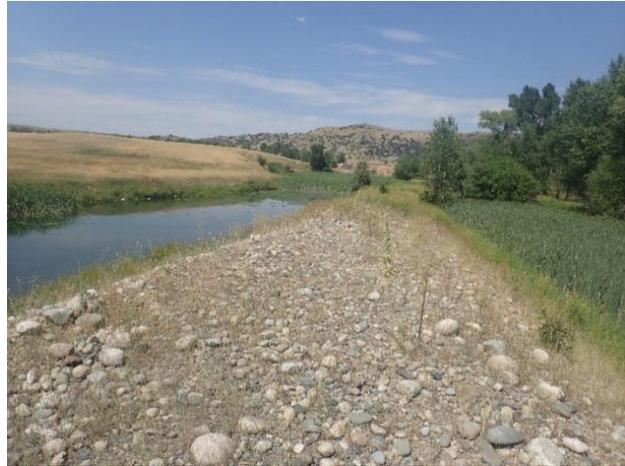
Site G-north river bank: A series of large cobble dikes, up to 30 feet wide, were constructed near the mouth of Buck Creek. Shallow wetlands have formed behind the dikes. The 1955 USGS topographic map shows that the main river channel passed through the current location of the dikes and wetlands. Between 1955 and 1975, the river channel shifted ~400 feet southeast. This channel shift may have prompted bank protection measures on the south river bank as discussed under Sites F, H, and I.

A large floodplain dike and wetlands located near the mouth of Buck Creek.

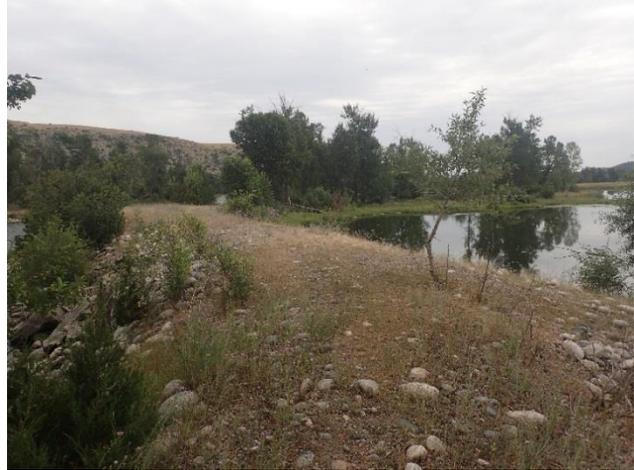
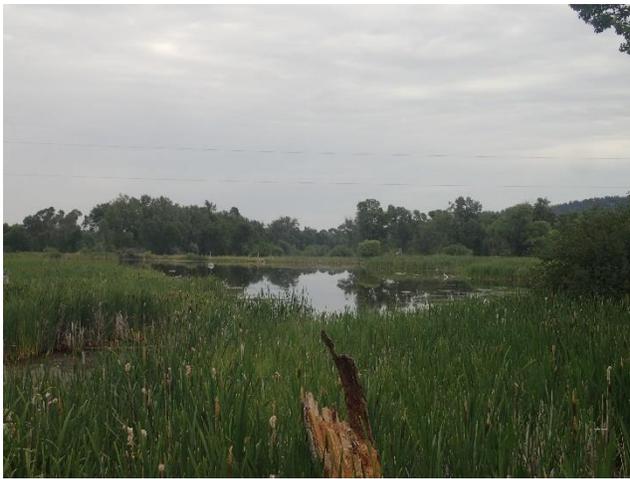
A large dike was built across a high-water channel over 60 years ago to protect the Whitebird Ditch.

A series of four wetlands have been constructed in the old high-water channel.

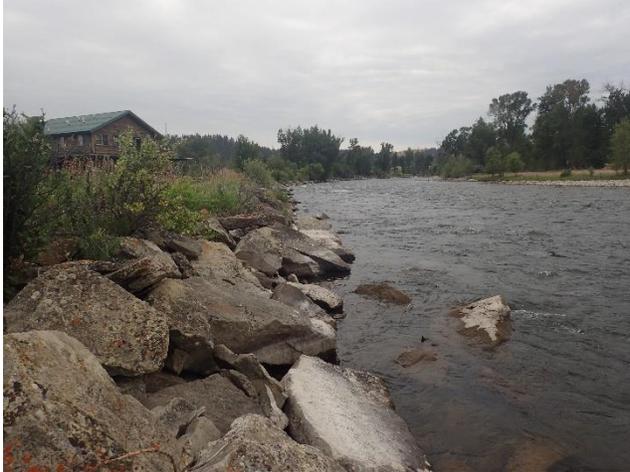
Rock rip-rap lines a long section of the east river bank.

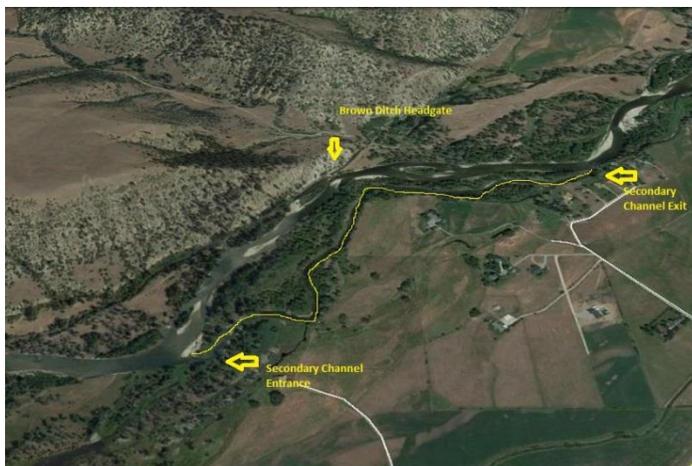
A secondary channel along the south bank could eventually be breached become the main channel. The secondary channel currently merges with the main channel at Site LSR-28, downstream from the headgate. If the main channel does breach into this secondary channel, the river could shift even further from the Brown Headgate.

The secondary channel is shown on the south side of the river (yellow line). If breached, the main river could shift away from the Brown Ditch headgate.

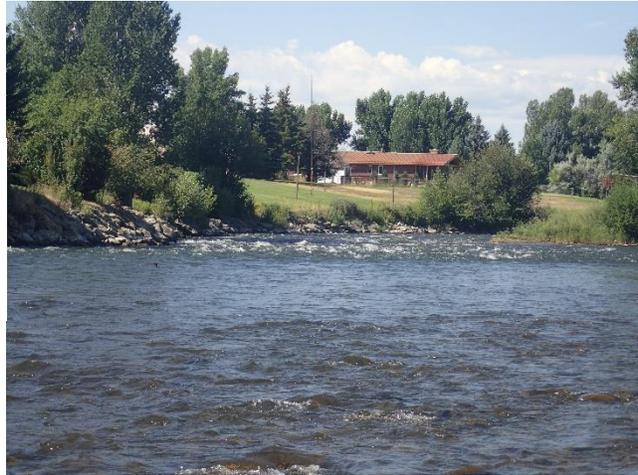
All River Meadows Subdivision tracts are located on a high river bank above the 100-year floodplain.

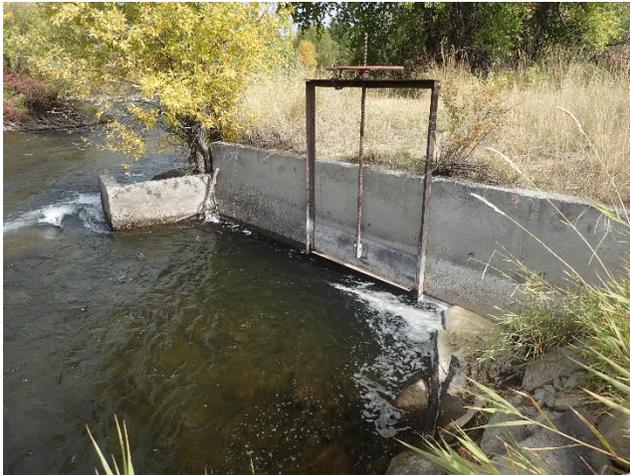
The Scott Ditch headgate is located on a secondary channel on the upstream end of the Whitebird Fishing Access Site (Site LSR-30). The headgate is a concrete structure with a metal slide gate. Over the last 65 years, the river has gradually shifted south making the secondary channel progressively larger. A cross-channel concrete check structure was part of the headgate system when the secondary channel was smaller. The check structure has since been replaced with a 40-foot long rock diversion angled 45° upstream from the headgate.

The Scott Ditch headgate is located near the mouth of a secondary channel upstream from the Whitebird Fishing Access Site.

Scott Ditch: The Scott Ditch irrigation system is 120 years old. A comprehensive system-wide evaluation of water conveyance efficiency, infrastructure condition and functionality, fish entrainment, and noxious weed mapping would serve as the basis for a long-term capital improvement plan that would provide prioritization and scheduling of system improvements.

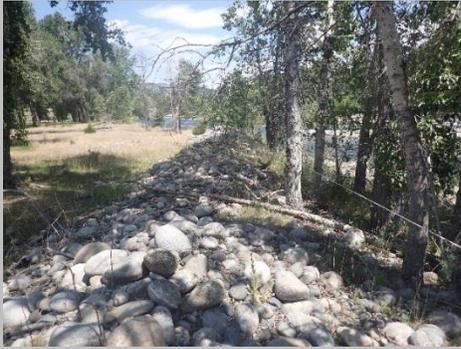
Old cobble floodplain dikes are common along Reach LSR3. These dikes block historic flood channels intended to protect agricultural infrastructure, roads and houses built on the floodplain.

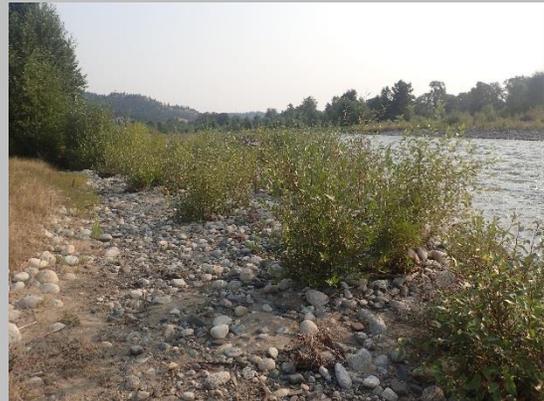
Black cottonwood trees sprouting along the river's edge provide age diversity essential to long term riparian forest sustainability.

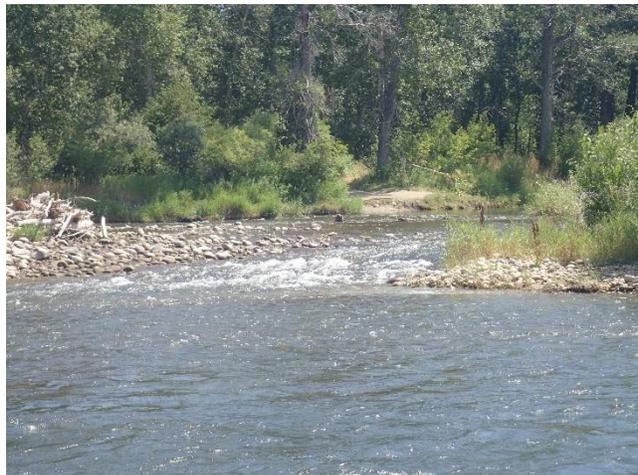
A large gravel bar has formed along the Whitebird FAS making it difficult for floaters to use the ramp.

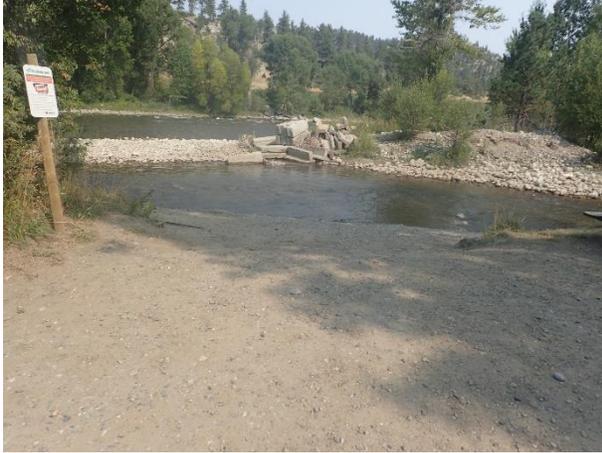
On the north end of Swinging Bridge FAS, a secondary channel is kept open to maintain flow to the Shane Ditch headgate.

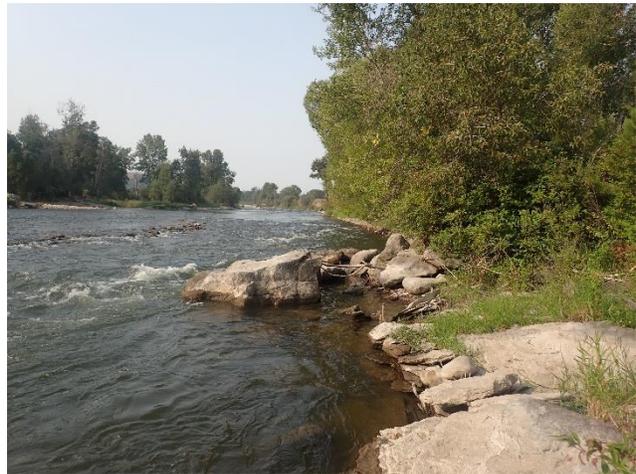
West Bank: Across from the Swinging Bridge FAS on the west bank, a series of large rock flow deflectors have been intermittently spaced along the toe of an 8-10-foot-high terrace. It is not clear why the deflectors were installed, possibly to protect a hay field and ranch road on the terrace. The bank is eroding between the deflectors due to their inadequate spacing. Bank saturation during the irrigation season exacerbates the problem. Exposed bedrock along the bank provides both natural flow deflection and bank armoring.

A series of flow deflectors line the west river bank across from the Swinging Bridge FAS.

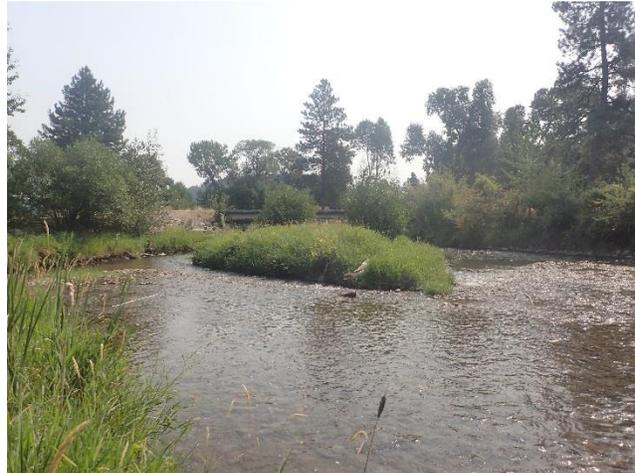
A large sediment “island” on the upstream side of the secondary channel bridge.

When it becomes necessary to replace the secondary channel bridge, it should be designed to better accommodate high flows and bedload.

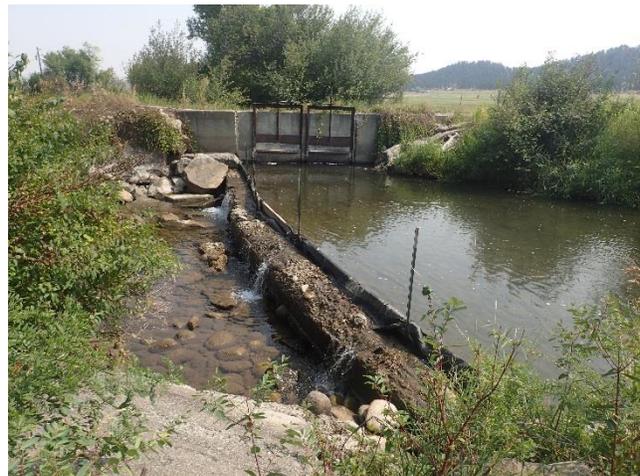
The Shane Ditch headgate is located on a secondary channel, southeast of the main channel. The headgate is a concrete structure with two steel slide gates. A 3-foot high X 45-foot long concrete sill across the channel elevates water to the headgate inlet. The headgate structure is in fair condition; however, a wing wall has separated from the headgate.

Shane Ditch headgate and cross-channel check structure are located on a secondary channel.

- 1) Check Structure: Replace the cross-channel check structure with a series of 2-3 rock lifts at the headgate. This lift design would provide better long-term stability and accommodate fish passage.

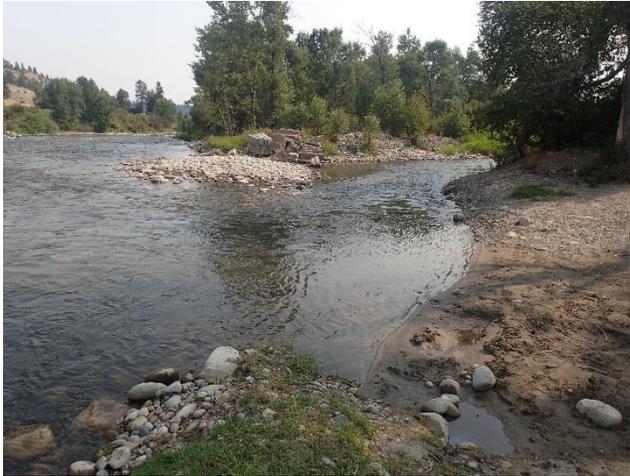
A secondary channel on the north side of the Swinging Bridge FAS conveys water to the Shane Ditch headgate. The Shane Ditch water users occasionally use concrete blocks to divert late summer low flows into the channel.

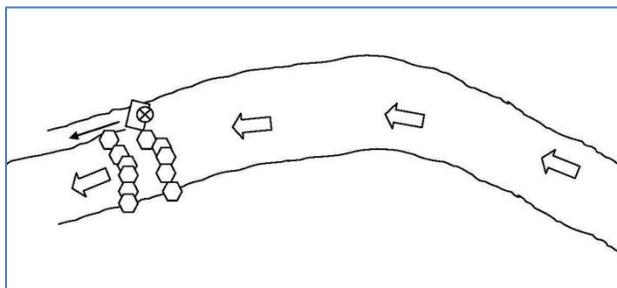
Conceptual drawing of large rock lifts that would replace the concrete sill.

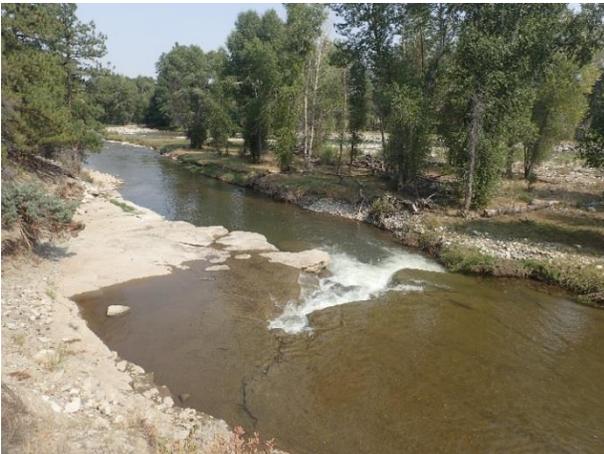
Across the river from Site LSR-37, an exposed bedrock shelf crosses a secondary channel with a 2-3-foot drop.

Exposed bedrock shelf traverses a secondary channel.

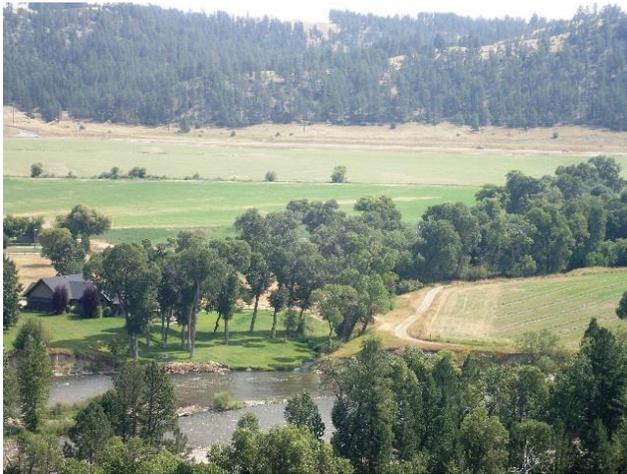
At the Joe Hill Creek confluence with the Stillwater River, a hay field was converted to a private residence about 12 years ago. This conversion included riparian clearing and landscaping to the edge of the creek. The confluence is on an outside bend along a braided section of the Stillwater River. Active terrace erosion is evident on both sides of the Joe Hill Creek confluence. Brush and lawn clippings have been piled on the eroding bank intended to curtail the erosion.

Joe Hill Creek enters the Stillwater River from the south.

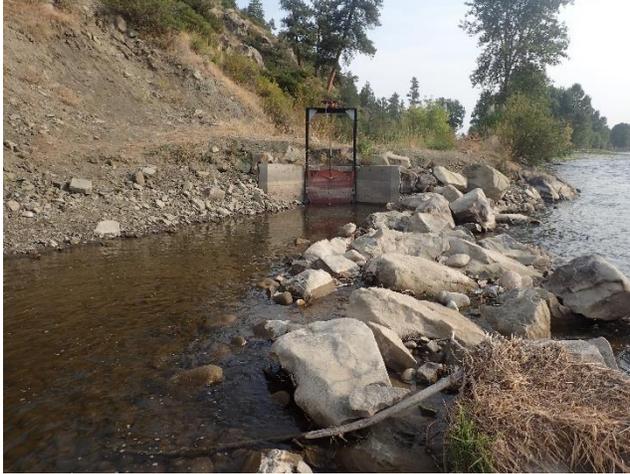
This irrigation headgate is located on the west river bank, upstream from a high-water channel. The headgate is a concrete structure with a slide gate and large rock diversion that extends upstream ~40 feet. The headgate structure is in fair condition, although wing wall footing are becoming scoured. The irrigation ditch follows the toe of a large bluff, past the Fireman's Point FAS (Site LSR-42), and into the Yellowstone River valley. An in-ditch water control structure is located 750 feet down from the headgate. The irrigation system has not had much use in recent years. It would be difficult to get sufficient water into the headgate during late summer months and the ditch is choked with vegetation.

Large angular rock rip-rap has been placed on 450 feet of river bank downstream from the headgate between the ditch and river. The lack of size diversity in the rock has resulted in scouring and sloughing of rip-rap down the bank. Bedrock has been exposed in the river bank above the headgate.

The irrigation headgate has a short rock diversion extending into the river channel.

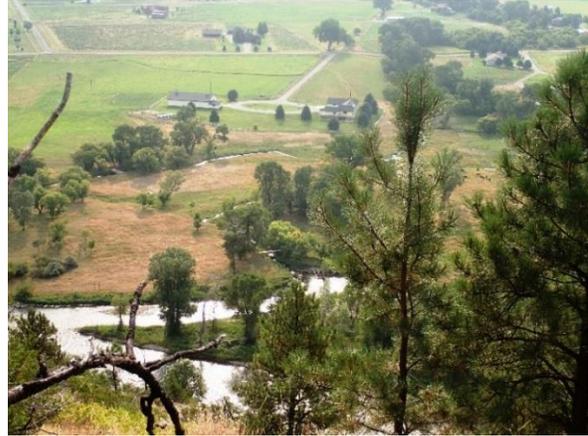
Most of the development in the Shane Creek Ranch Subdivision has taken place outside the 100-year floodplain.

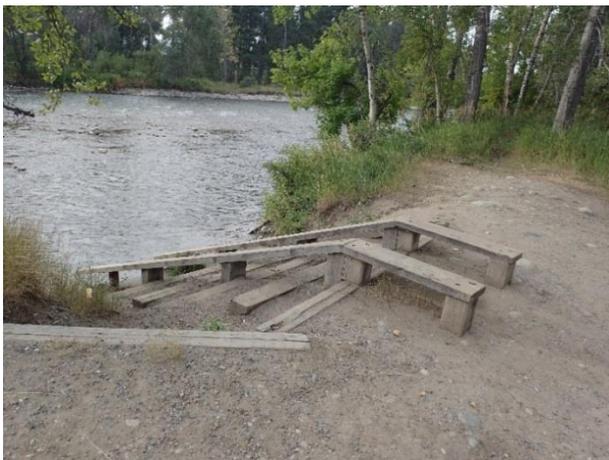
Slide launch for rafts was recently added to the Fireman’s Point Fishing Access Site.

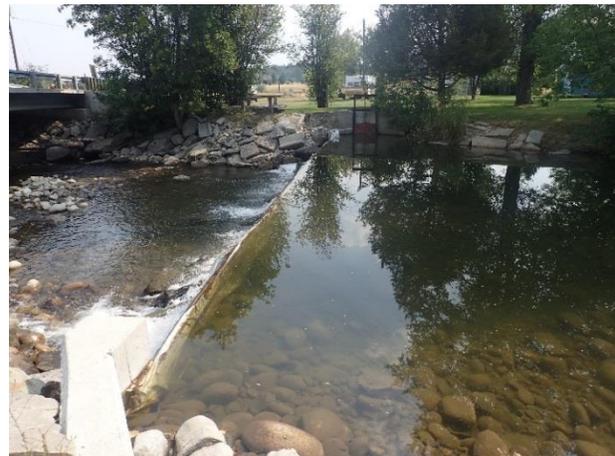
The White Ditch headgate and cross-channel check structure are located on a secondary channel.

- 1) Headgate: The headgate structure needs to be replaced in the immediate future.
- 2) Rock Ramp: Place a rock ramp between the top of the concrete headgate sill and the bridge grade control sill. Remove jack legs and boards after each irrigation season. This lift design would provide long-term stability and accommodate fish passage.
- 3) White Ditch Evaluation: The White Ditch irrigation system is nearly 120 years old. A comprehensive system-wide evaluation of water conveyance efficiency, infrastructure condition and functionality, fish entrainment, and noxious weed mapping would serve as the basis for a long-term capital improvement plan that would provide prioritization and scheduling of system improvements.

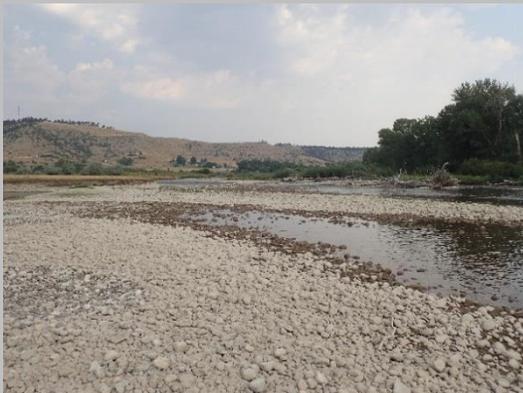
The river channel near the Stillwater/Yellowstone confluence is wide and shallow with large gravel bars.

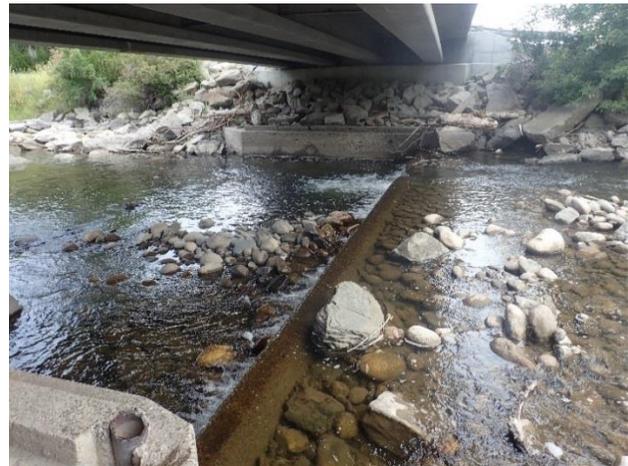
Countryman Creek Road Bridge has mid-channel supports that catch woody debris. A large gravel bar has formed on the downstream side of the bridge.

The bridge across the secondary channel has a cross-channel grade control sill beneath it.
