Stillwater River Flood Rehabilitation River Assessment Triage Team (RATT) 2023 Summary Report Prepared for:

## Stillwater Valley Watershed Council

Karin Boyd Applied Geomorphology, Inc.

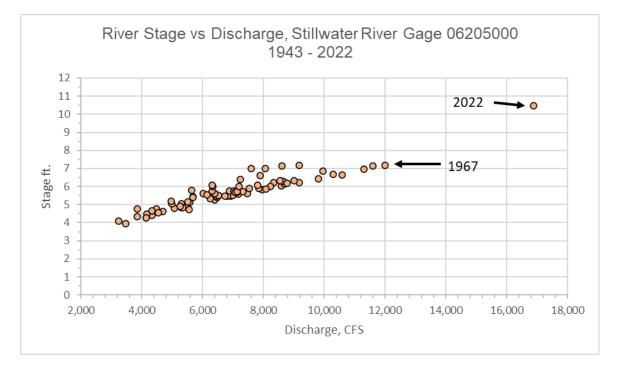
Figure 24. Stage-discharge data for Stillwater River (USGS 06205000). Source USGS, 2023.

A plot of river stage versus discharge for all annual floods from 1943 through 2022 is shown in Figure 24. The stage-discharge relationship is quasi-linear for all points except for the 2022 flood, which, at 10.49 ft is far higher than any previous flood. Since large floods can induce scour or aggradation of the streambed, or erode banks near the gage, it is possible that with further study, the USGS and/or NWS may be revising the stage-discharge datum. Note that the relationship between river stage and discharge can vary due to changes in channel geometry over time.

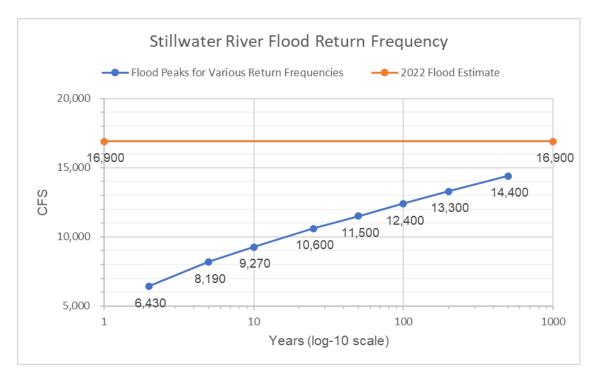
Figure 25. Stillwater River Flood Magnitude vs. Flood Interval compared to the June 2022 Flood (Source: USGS, 2023).

A comparison of the June 2022 peak flow with a standard chart of flood flow versus predicted return intervals ranging from the 2-Year through the 500-Year flood is provided in Figure 25. The trajectory of the plotted line suggests that the return interval of the June 2022 flood was, for the Stillwater River, well beyond a 500-year event, and beyond the range of prediction by standard hydrologic statistics.

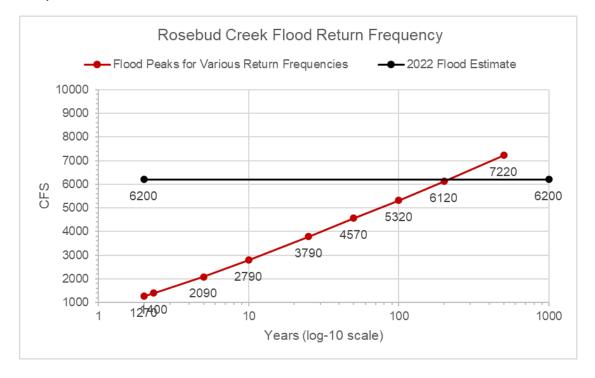
Figure 26. Rosebud Creek Flood Magnitude vs. Flood Interval. (Source: USGS, 2023)

A similar chart for Rosebud Creek near the mouth is provided in Figure 26. The USGS used surveys of peak flood watermarks and channel geometry to indirectly calculate the peak flow for the 2022 flood. The peak of 6,200 CFS is equivalent to about 37% of the total peak of 16,900 CFS determined at the USGS gaging station below Absarokee.

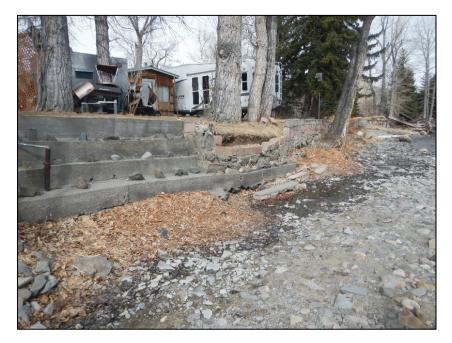
Figure 31. Cement retaining wall on streambank in area of small tract development, Stillwater River.

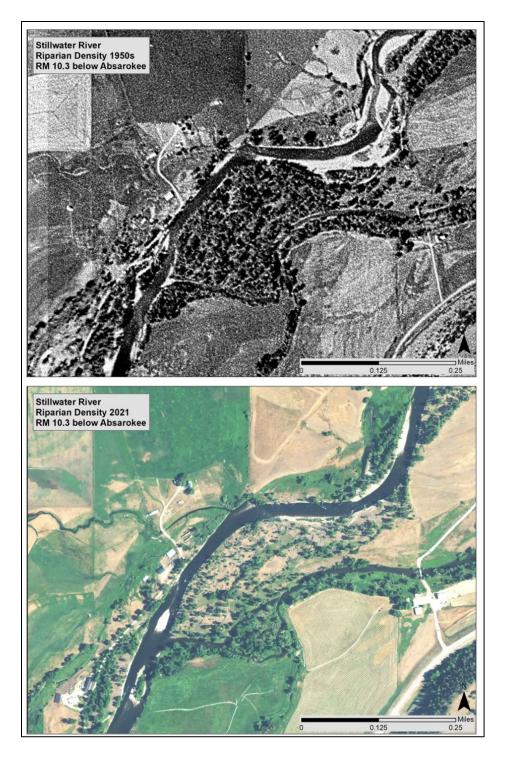
Although the rivers evaluated commonly have broad cottonwood-dominated riparian corridors, there has been some local losses in the density of woody floodplain vegetation since at least the 1950s (Figure 32). This may reflect management activities (e.g. clearing or herbicide application) or loss of natural cottonwood regeneration processes such as lateral channel migration that can result in "aging out" of riparian stands. The implications can be substantial regarding floodplain roughness and integrity, both of which can dissipate flood energy and support habitat.

Figure 32. Example loss of woody riparian density since the 1950s, Stillwater River at RM 10.3

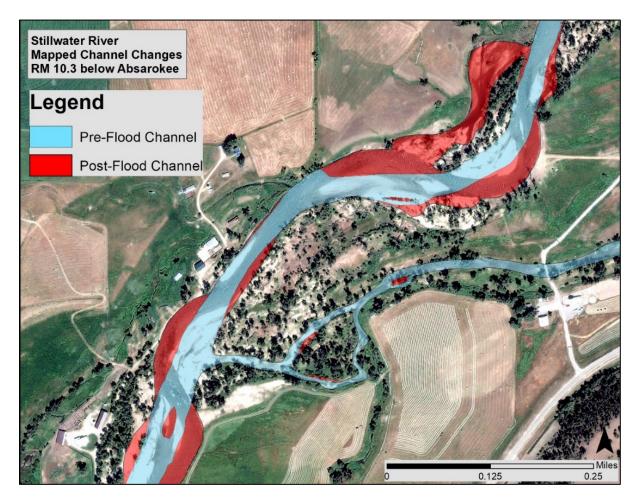
Bank erosion was one of the most extensive and visible flood impacts. In order to better understand the locations and extent of flood-induced erosion, the pre- and post-flood banklines were intersected to estimate the acreage of ground eroded during the flood event (Figure 39). These data can also be used by individual landowners who would like to measure the amount of erosion or channel widening on their property.

Figure 39. Example bankline mapping showing pre- and post-flood banklines capturing erosion location and extent, Stillwater River RM 10.3 below Absarokee.

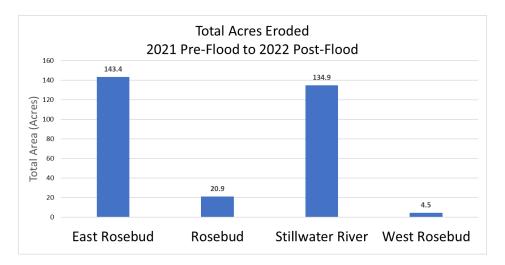
Figure 40. Total extent of erosion during the June 2022 flood window by river sub-basin.

For the reaches evaluated, just over 300 acres of total ground was mapped as eroded due to bankline shifts during the flood, with the vast majority on the Stillwater River and East Rosebud Creeks (Figure 40). Rosebud Creek at Absarokee is only 3.8 miles long, such that the total erosion was less than other streams but proportionately heavily eroded. West Rosebud Creek shows relatively minor erosion along its 23-mile length.

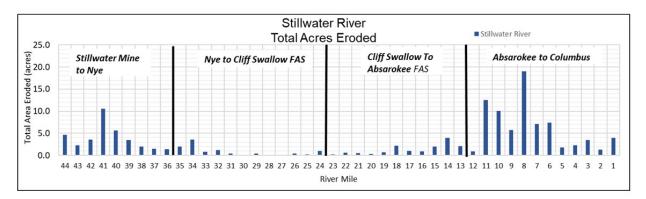
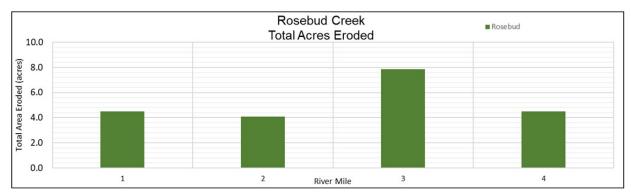
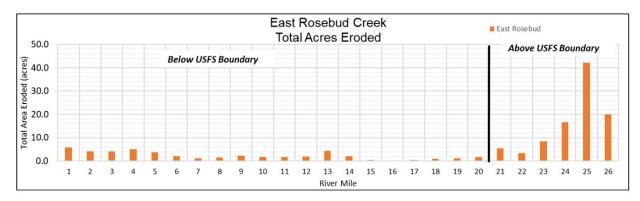
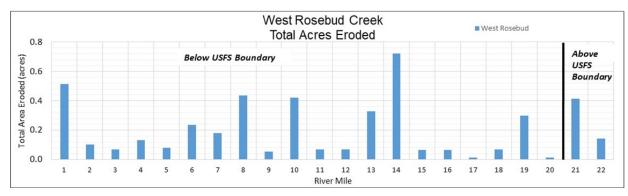
Figure 41. Total acreage eroded by river mile, (RM 1 value reflects eroded acres erosion from RM 0-RM 1; note that the scale of the vertical axes varies greatly between the plots.

Figure 41 shows the amount of erosion by 1-mile increments for each stream, to help highlight the most impacted areas. On the Stillwater, erosion was clearly most intense on the upstream end near the Sibanye-Stillwater Mine as well as just above and below the Rosebud Creek confluence. Much of the

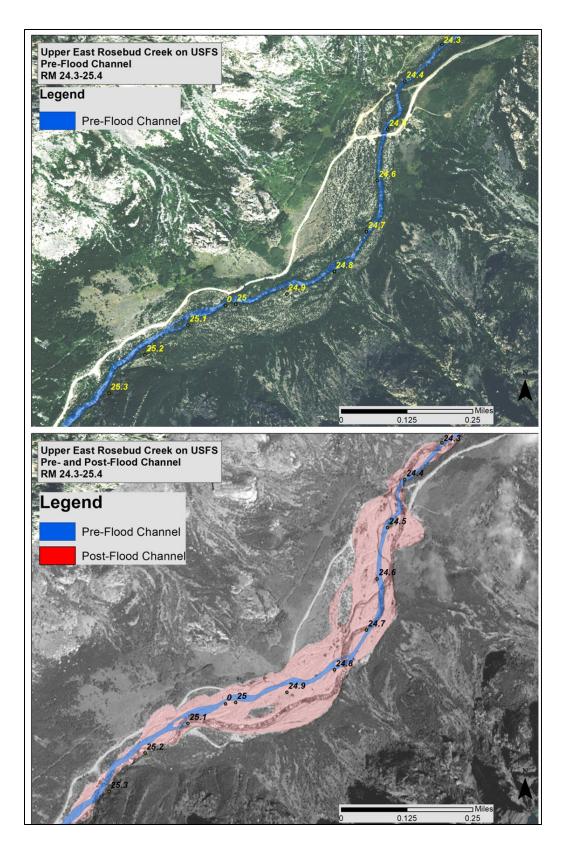
Although East Rosebud Creek showed 143 acres of total erosion, the majority of that was in the upper watershed above the USFS boundary where erosion/gravel deposition was especially intense (Figure 43).

Figure 43. Pre-flood (top) and post-flood (bottom) imagery from East Fork Rosebud Creek above USFS boundary.

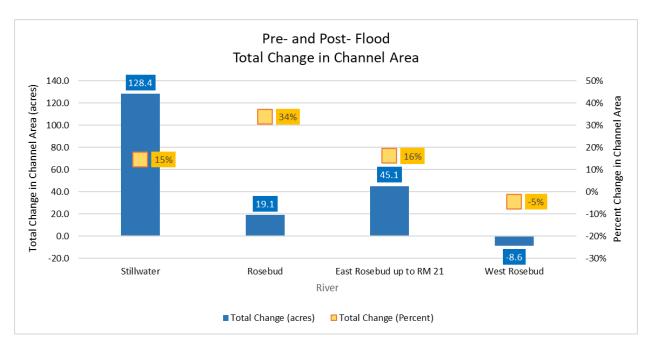
Figure 44. Total flood-driven change in channel area (aerial footprint) by river sub-basin.

Whereas the erosion patterns described above capture channel migration, the percent change in total aerial footprint of the pre- and post- flood channels gives some indication of channel widening. Figure 44 shows the total change in channel footprint for all the streams evaluated. The Stillwater River expanded by 128.4 acres, which reflects a 16% expansion in total area. In contrast, West Rosebud Creek showed minimal change in area; the results indicate that West Rosebud Creek became slightly smaller after the flood due to local side channel abandonment.

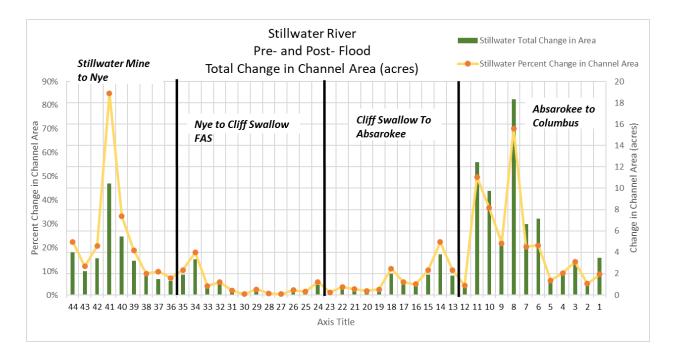
Figure 45. Total acreage of channel expansion (bars) and percent channel widening (lines) by river mile for the Stillwater River. Changes in the size of the channel footprint is shown on right-hand axis; percent change is on left-hand axis.

The greatest overall expansion of the channel on the Stillwater River was on the upper end near the Sibanye-Stillwater Mine, and below Absarokee (Figure 45). The changes above Nye reflect only widening, whereas the changes below Absarokee reflect channel widening as well as new channel formation (avulsion). Figure 46 shows dramatic channel widening near the Sibanye-Stillwater Mine above Nye where several structures were lost during the flood.

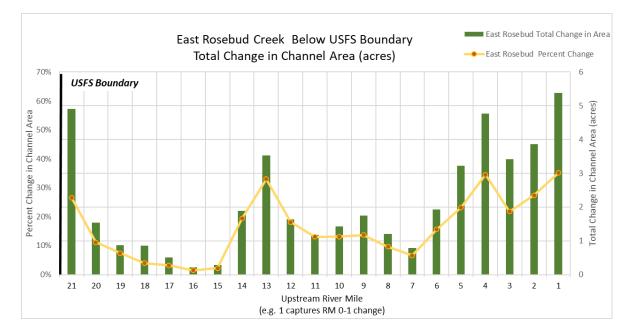
Figure 47. Total acreage of channel expansion (bars) and percent channel enlargement (lines) by river mile for East Rosebud Creek.

Figure 47 and Figure 48 show the locations of channel enlargement on East Rosebud Creek and Rosebud Creek, respectively.

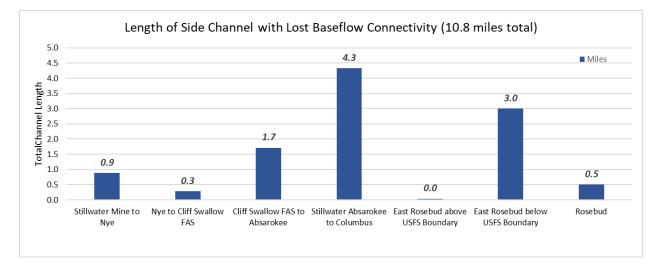
Figure 51. Mapped length of side channels that show lost baseflow connectivity due to sediment deposition.

erosional cuts was re-deposited in the next bar or two downstream, typically a distance of 500 to 1,000 feet. Lighter materials on the other hand traveled considerable distances. In one telling incident, a Stillwater River rancher lost dozens of large round bales to bank erosion near mile 13.7, and one of those bales was found embedded in a new cobble bar near river mile (RM) 11, about 2.7 miles downstream. There are currently no data available to quantify the extent of channel infilling, however it was possible to map side channels that appear to have become disconnected at low flow due to deposition (Figure 49). An estimated 10.8 miles of channels have become perched due to deposition, some of which have sediment concentrated at their entrances and others throughout their length (Figure 50 and Figure 51).

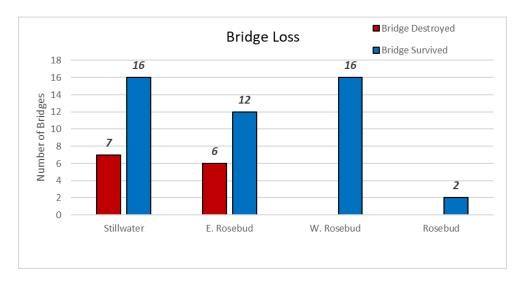
Figure 53. Total number of bridges mapped as having survived or been destroyed by the flood.

A total of 59 bridges were mapped in the assessment reaches, and 13 of those were completely destroyed by the flood. All the destroyed bridges were on either the Stillwater River or East Rosebud Creek. Several bridges provided primary access for residences such as the Rainbow Ranch Subdivision on the upper Stillwater (Figure 53). Other bridges visited in the field were substantially damaged but did not fail.

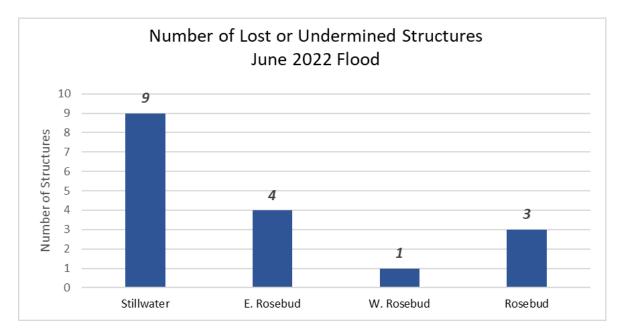
An estimated total of 17 structures were identified in the mapping as having been destroyed or undermined by the flood, including approximately 13 homes and 4 outbuildings (Figure 55). The majority of those were on the upper Stillwater, with 9 structures identified upstream of Nye. Most of the structures destroyed upstream of Nye were residential homes (Figure 56).

Figure 55. Number of mapped structures destroyed by 2022 Flood; most were residences.

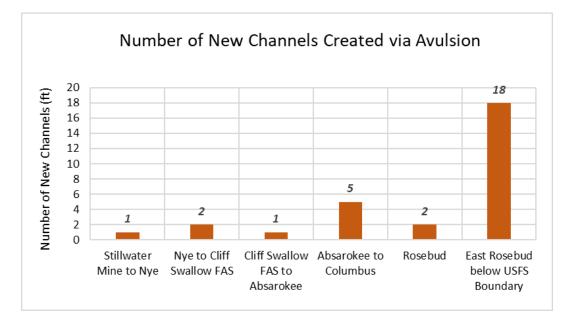
An *avulsion* is the rapid carving of a new channel through a floodplain surface that captures flow of the main channel thread. A total of 29 avulsions were mapped in the assessment area, with the majority occurring throughout the riparian bottomlands along East Rosebud Creek below the USFS boundary (Figure 58). About 5.2 miles of new channel formed, with almost half of that total length on East Rosebud Creek (Figure 59). Some of these channels will decay with time, especially if they did not erode deeply enough to carry typical flows. Some will persist as main channel threads. Although avulsions can create problems due to the dramatic channel change, they can also create beneficial habitat complexity and rejuvenation where infrastructure is not directly threatened (Figure 60).

Figure 58. Distribution of mapped flood-induced avulsions.

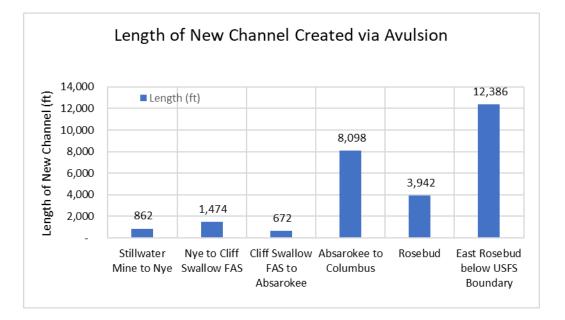
Figure 59. Length of mapped flood-induced avulsions.

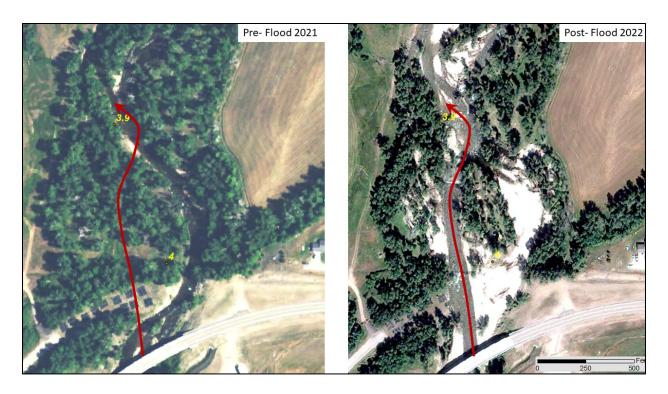
Figure 60. East Rosebud Creek below the new Highway 78 Bridge showing 2021 image (left) and post- flood 2022 image (right), with avulsion route mapped in red.

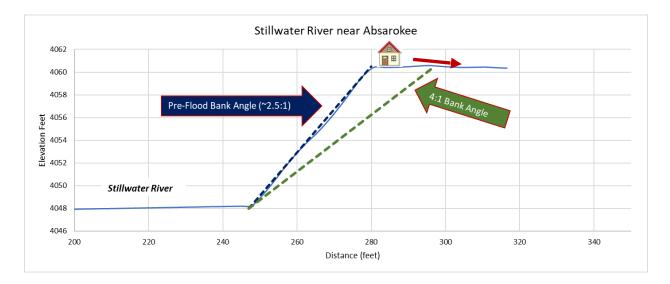
Figure 62. Example Stillwater River bankline where landowner had to place emergency riprap to protect home on steep bank near Absarokee.

- 10. Encourage residential construction to incorporate a setback defined by a minimum interpolated slope angle of 4:1 from the low water's edge to the top bank (Figure 62).

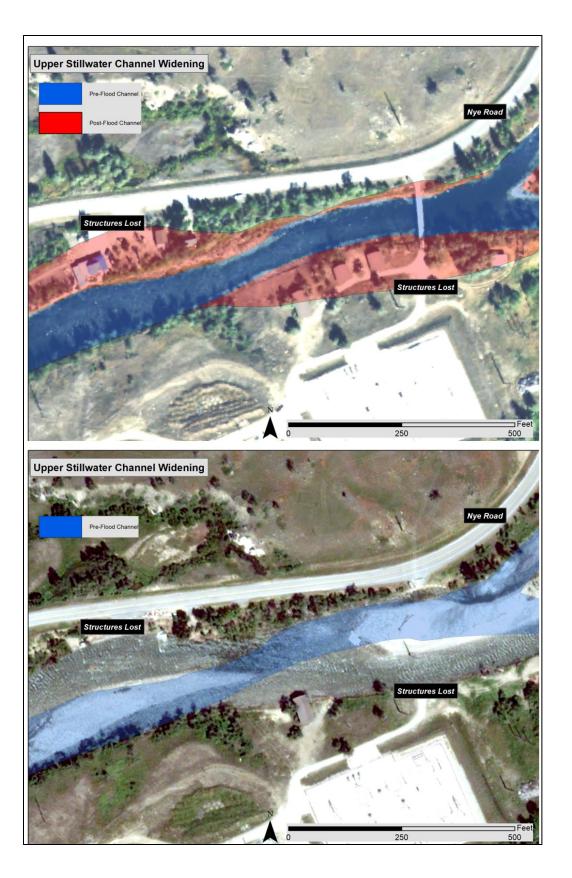
historic flood resistance along miles of bankline. Much of the erosion was accompanied by major sediment deposition and channel widening. This includes areas dominated by very coarse bedload such as on the Stillwater River above Nye (Figure 63), where the channel width more than doubled and bar formation "flipped" the planform creating new cutbanks against structures. Downstream, the rapid deposition of point bars drove erosion of the opposite banks, creating a more sinuous planform (Figure 64). In some cases, residences were directly threatened, but in many others the concern is not related to infrastructure but the general loss of ground. On Rosebud Creek where point bars developed and drove massive erosion during the flood event, post flood adjustments included the natural re-routing of the channel away from the eroding bank, greatly reducing the threat to the homes (Figure 64 and Figure 65).

Figure 63. Stillwater imagery from pre-flood (top, erosion shown in red) and post-flood (bottom, pre-flood channel shown in blue) showing channel widening from about 80 feet to 200 feet.

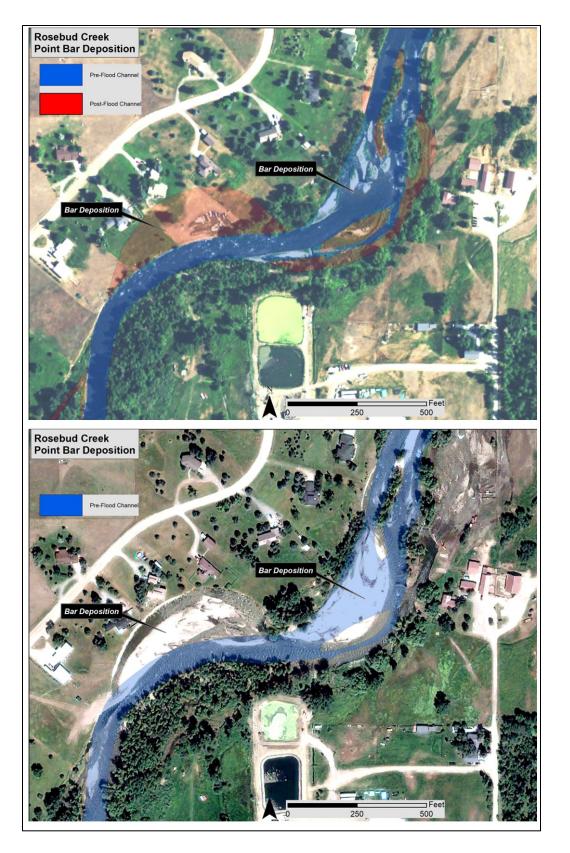
Figure 64. Rosebud Creek imagery from pre-flood (top, erosion shown in red) and post-flood (bottom, pre-flood channel shown in blue) showing large bar formation and associated bank erosion.

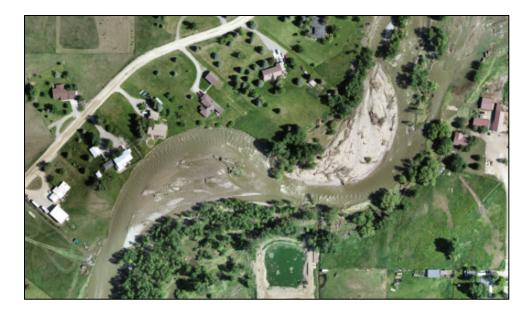
Figure 65. Erosion intensity visible at site shown in Figure 64 during the flood event; the channel flowing against the homes was diverted with a dike to the south, reducing the property threat (see Figure 64). The berm has since been removed.

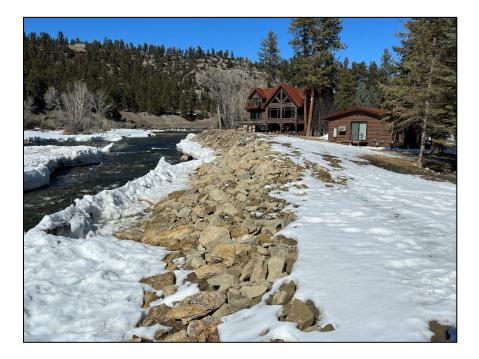
(Figure 67). In other areas, erosion sites can be monitored or treated with wood structures to provide near-term flow deflections in areas of high energy as the river continues to evolve post-flood. As the river used to have natural boulder accumulations that provided some bank toe protection, those can be rebuilt using local materials (potentially using the larger material deposited on the opposite bank to redevelop the coarse toe (Figure 70).

Figure 67. View downstream on lower Stillwater showing recently armored bankline extending above natural floodplain elevation.

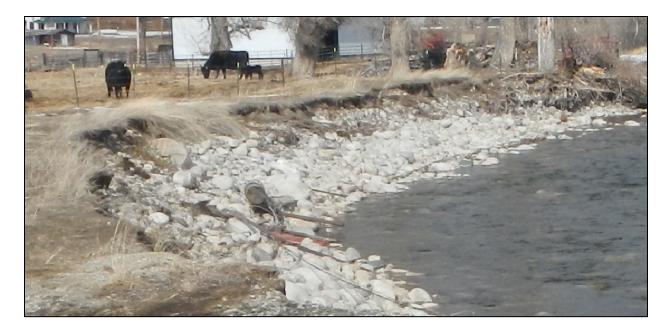
Figure 70. Natural analog for using locally derived rounded boulders to reinforce bank toes.

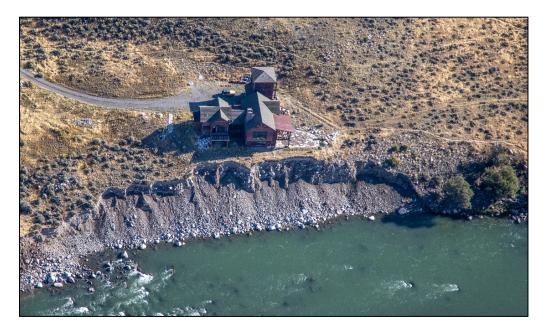
Figure 71. Example high terrace erosion threatening home on upper Yellowstone River, June 2022 (Kestrel Aerial Services).

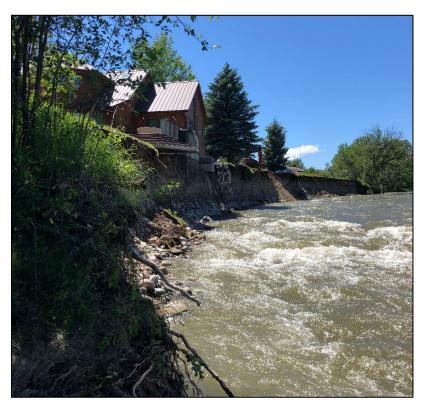
Figure 72. High bank residence being actively undermined during flood, Stillwater River.

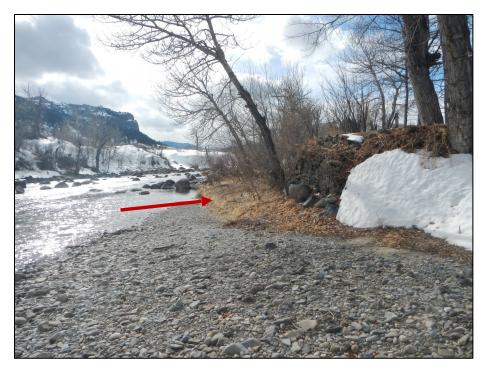
Figure 75. Natural analog showing bankfull bench supporting woody vegetation.

In the event encroachment into the channel is necessary, integrating a bankfull bench against the river into bank treatments provides opportunities for riparian vegetation to develop which adds further protection (Figure 75).

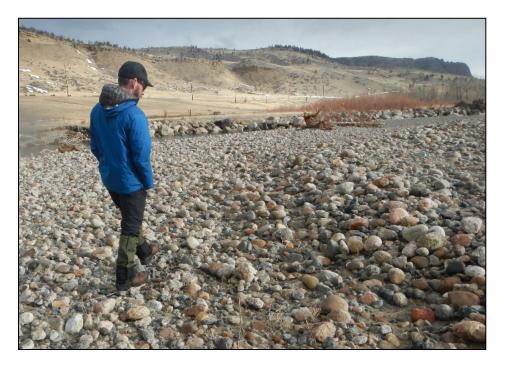
The depositional patterns described above have created massive new bar deposits that have reduced overall channel capacity in some areas (Figure 77). This material can be very coarse, perched high above typical stream stages, and thus largely immune to future reworking under normal flow conditions. These in-stream features have fundamentally altered planform and created erosion issues on opposite banks. Excavating material from the channel has been discussed above, and there are opportunities to increase channel capacity without creating major negative impacts to in-stream habitat. This includes the focused excavation of blocked side channels to re-activate those channels and provide additional capacity (Figure 78). In some areas, only the side channel entrance would require excavation. Where side channels are reactivated, placing a wood jam at the head of the island can help keep side channels open into the future.

Figure 77. Coarse bar deposit created during flood event on upper Stillwater.

- 1. Reactivate side channels by excavating sediment/building apex log jams at heads of islands.
- 2. Skim tops of bars versus removing entire feature to maintain a low flow channel.
- 3. Retain wood jams and woody debris that aren't creating problems to improve habitat diversity.

4. Restore side channels that have aggraded to improve conveyance/habitat.

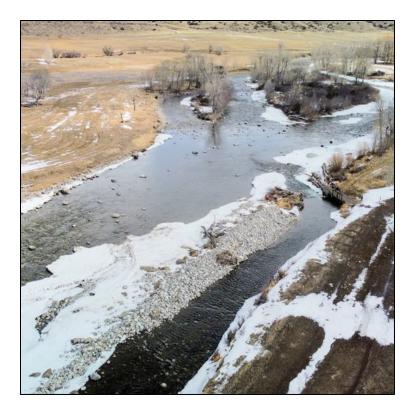
Irrigation infrastructure damage consisted of headgates and rock diversions getting overwhelmed by high water. The consequences included sediment/debris accumulations at headgates, complete headgate destruction, headworks erosion, and ditch flooding (Figure 87 and Figure 89). As each structure is different, so are recommended treatments. In some cases, irrigation diversions include rock weirs that extend diagonally upstream across the main channel (Figure 90). These structures inherently require more annual maintenance, as they tend to obstruct the downstream transport of sediment, carry excessive sediment into the ditch, block low flow channel threads, and pose an unavoidable hazard to floaters. Any designs developed to repair diversions should keep concepts of sediment transport and low flow conditions in mind, such that sediment is not excessively taken into the ditch, and the river retains a central thread of flow at low water.

Figure 87. View downstream showing Mendenhall Ditch Co. diversion that experienced major debris/sediment accumulations at headgate; material has been removed and structure is slated for additional repairs.

- 1. Clean out debris in approach channel.
- 2. Ensure that there is a high flow release structure down ditch if headgate overtopped.
- 3. Repair flanked headgates as necessary with rock.
- 4. When making repairs, mitigate fish entrainment at the diversion (consult FWP).
- 5. Where rock diversions extend into river, maintain a low flow thread in river to support the fishery, pass sediment, and reduce risks to floaters.
- 6. To avoid rock weirs that cross the main channel, extend rock diversions further upstream but with a narrower opening that does not protrude excessively into the river mainstream.
